# **YOUNG RIVER CATCHMENT**

## **FARMERS ROAD CREEK**

### **STREAM REHABILITATION DEMONSTRATION REACH**

#### **SITE ASSESSMENTS & OUTCOMES**

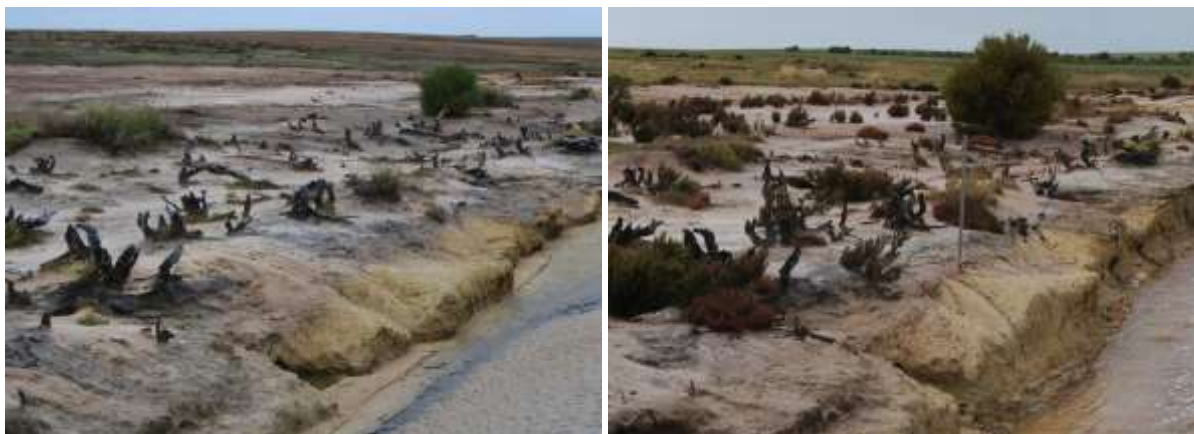
Photo Point 01 shows a marked increase in the coverage of Samphire across the valley floor.

**Figure 3: Photo point 01. 28<sup>th</sup> February 2011 and 10<sup>th</sup> June 2016. Self-sown Samphires are colonising the scald.**

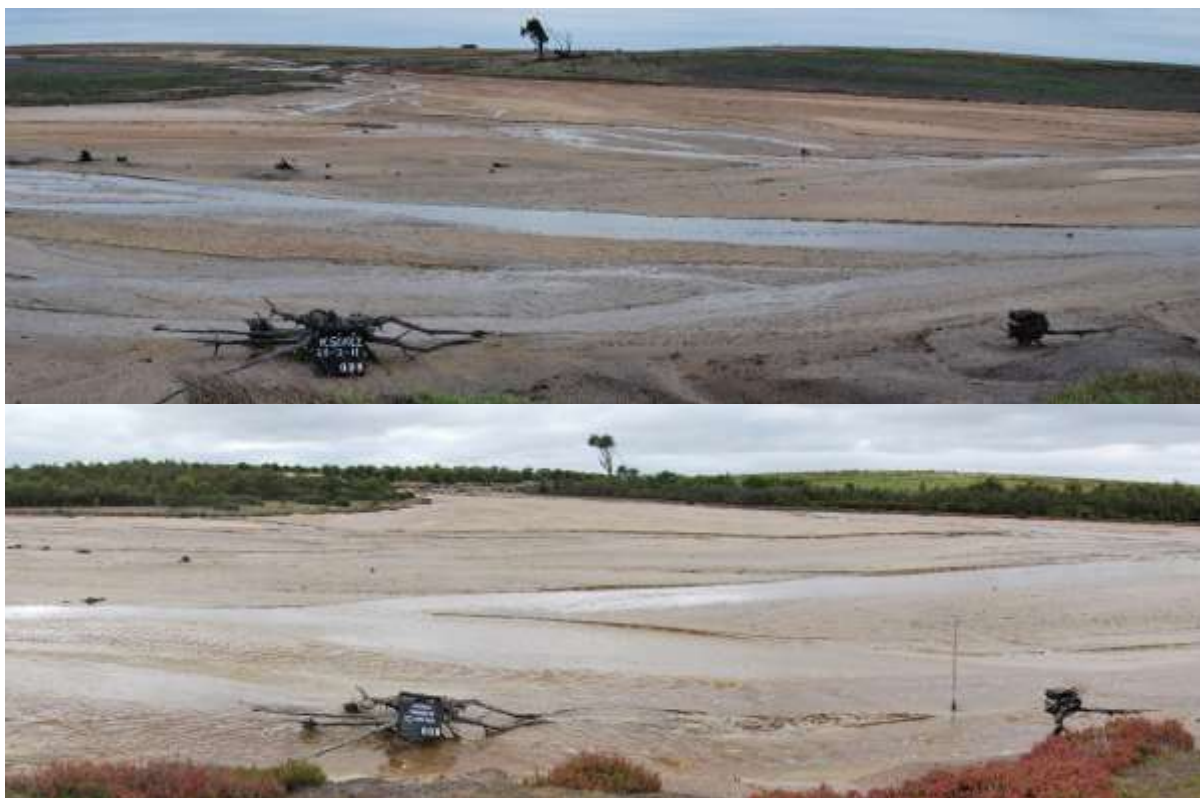
Photo point 08 shows little change across a broad sediment deposition area suggesting that conditions remain hostile to opportunistic colonisation by Samphires. It can be noted that the path of low water flow has been quite variable.

**Figure 4: Photo point 08. 28<sup>th</sup> February 2011 and 10<sup>th</sup> June 2016 looking across the channel to a tributary entering from the left bank.**

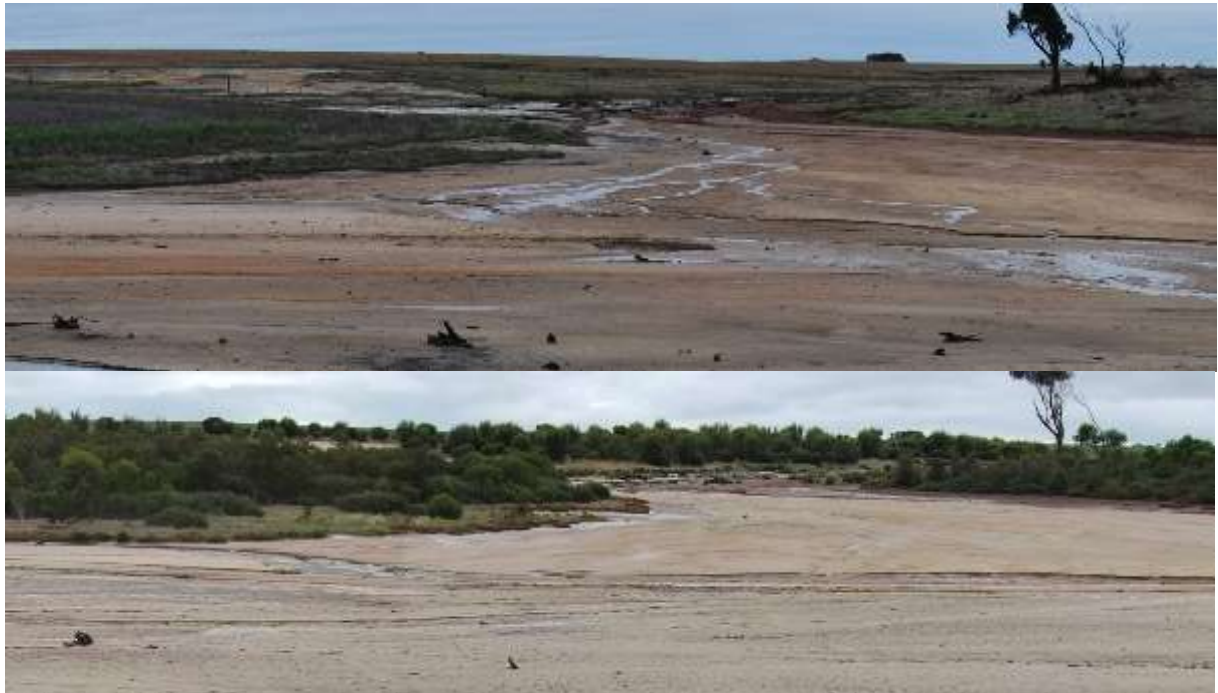
Photo points 08 and 12 show dramatic changes to the riparian verge although little has changed in the valley floor after 5 years. The direct seeding has clearly been successful by adding typical riparian structural elements into the environment.

Figure 5: Zoom in to Photo point 08. 28<sup>th</sup> February 2011 and 10<sup>th</sup> June 2016. Direct seeding on either side of a tributary entering the main channel.

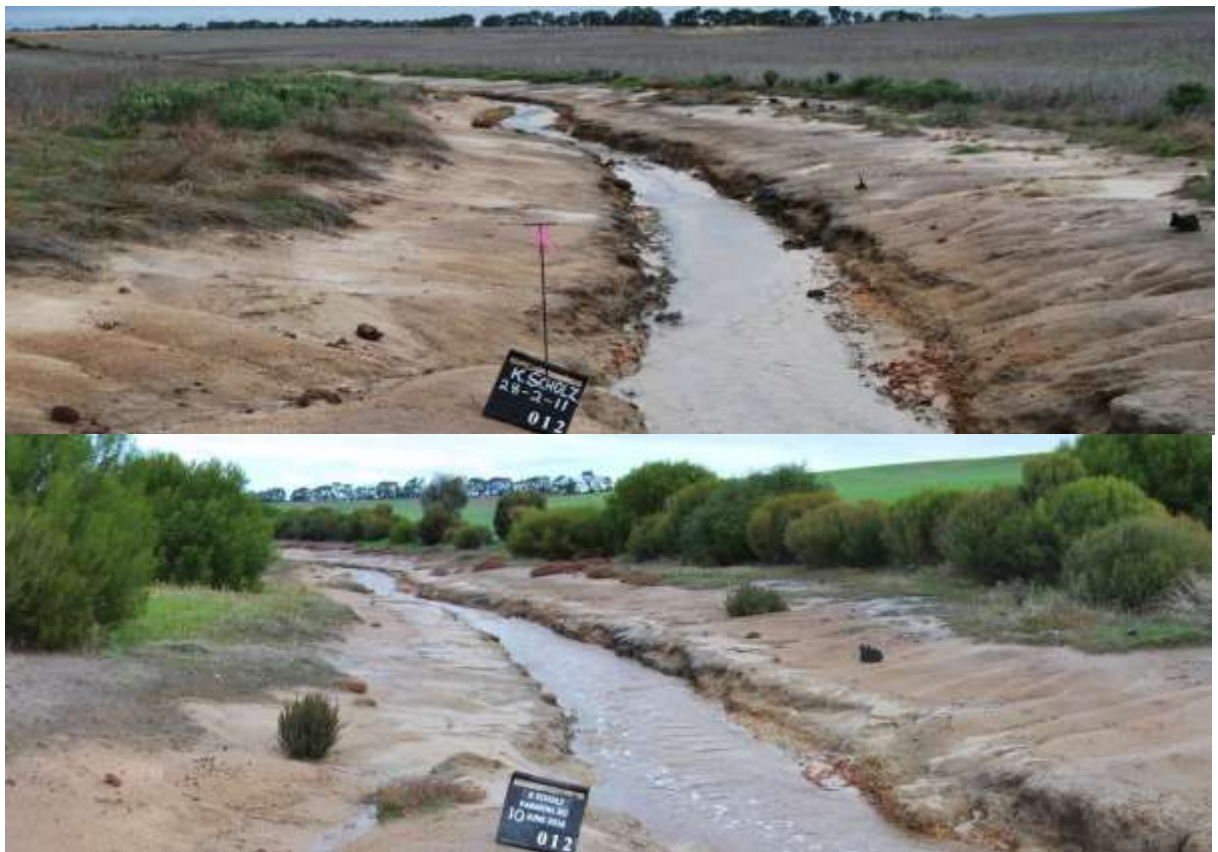
Figure 6: Photo point 12. 28<sup>th</sup> February 2011 and 10<sup>th</sup> June 2016. Healthy growth of planted seedlings.

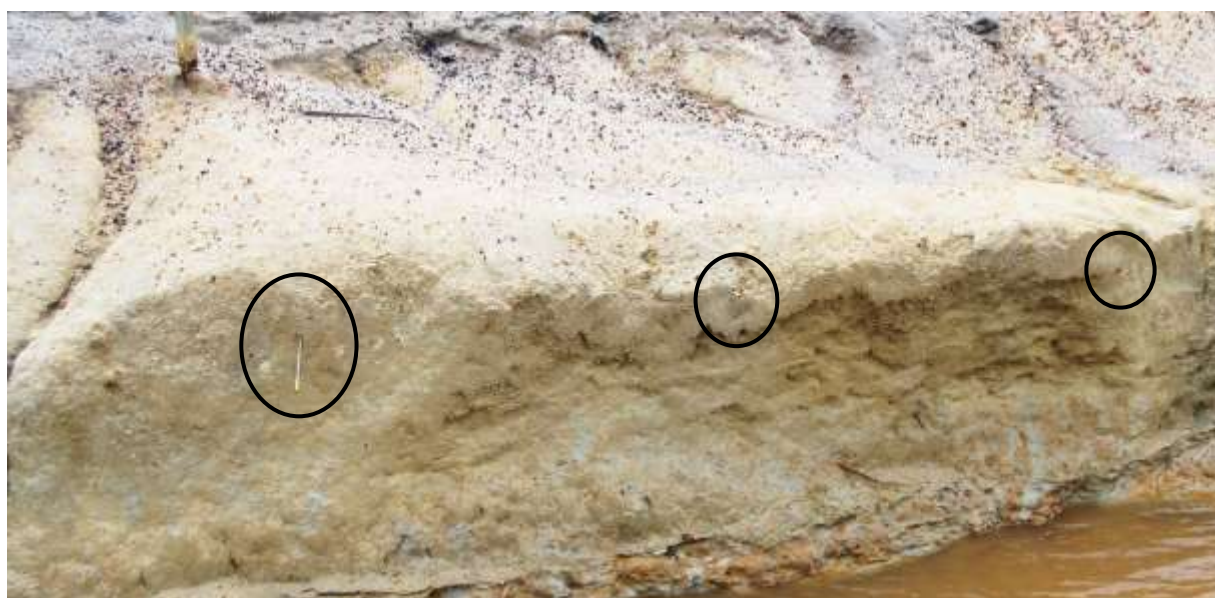
| <b>Lenth of pin exposed 2011-16</b> | <b>Erosion Pin 1</b> | <b>Erosion Pin 2</b> | <b>Erosion Pin 3</b> | <b>Mean pin exposure</b> | <b>Photo Points</b> |
|---|---|---|---|---|---|
| Erosion Pins G | 120 | 0 | 10 | 43 | PP01 |

**Figure 8: The erosion pin array at site G showing the variability across a 2 meter span.**

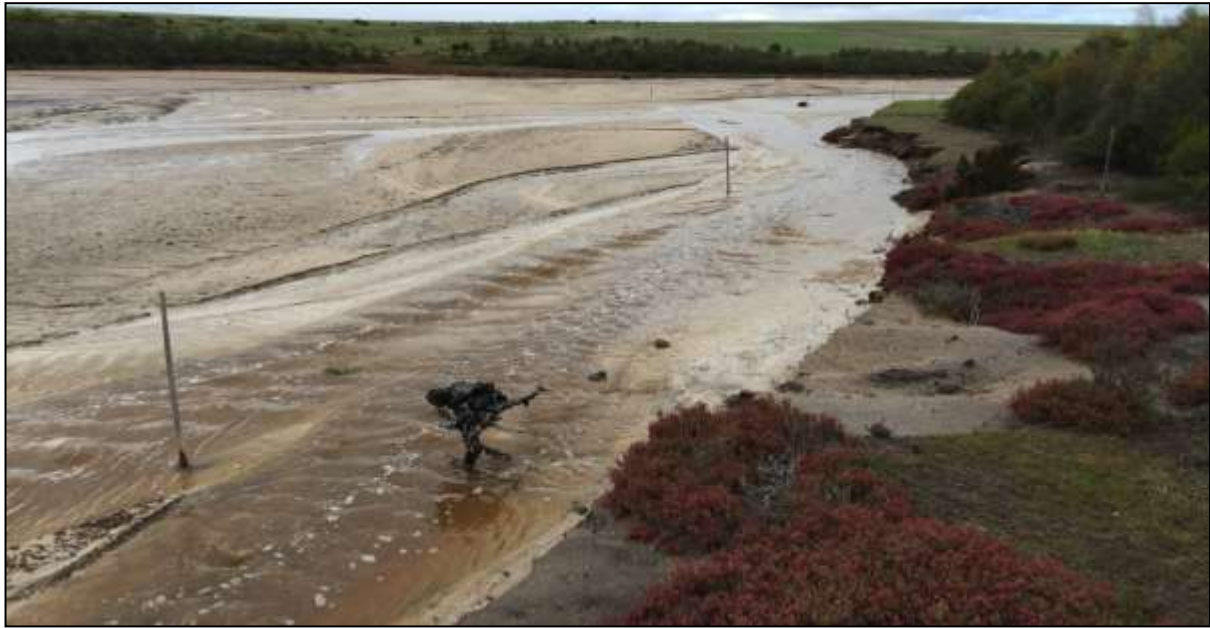
Pins at site E had been washed away, however several wooden stakes (Figure 9 below) had also been placed at this site in 2011 and showed that the edge of the bank had eroded back approximately 2 meters.

**Figure 9: Wooden stakes that had been placed on the edge of the bank in 2011. The receding bank was a relatively local feature along 50 meters of the channel and opposite an incoming tributary.**

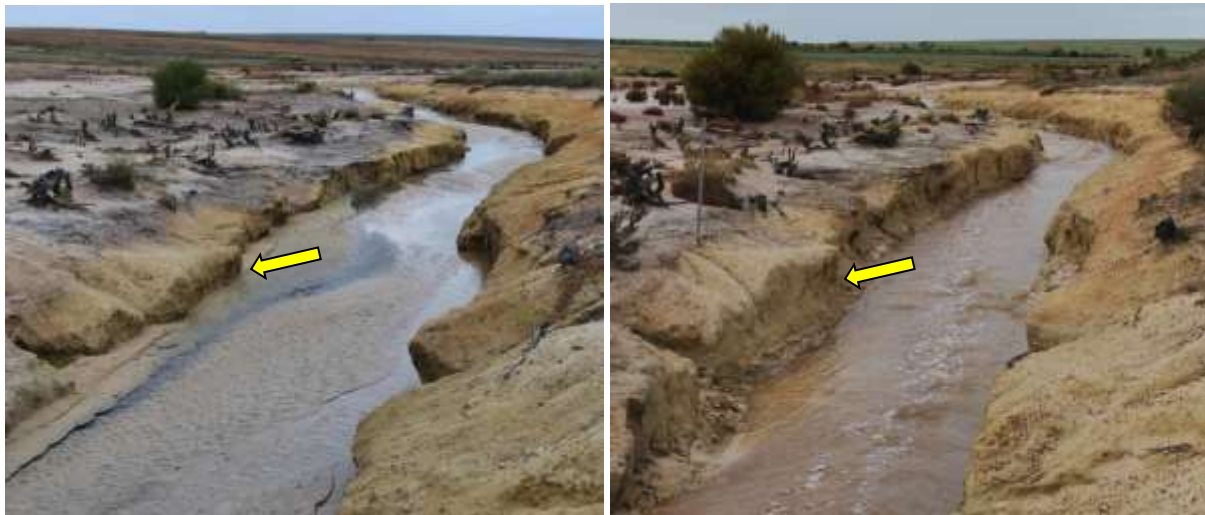
**Figure 10: Photo point 01. 28<sup>th</sup> February 2011 (left) and 10<sup>th</sup> June 2016 (right). Note the deepening of the channel observable in these photos.**

Site 01 is a short distance downstream of the road culvert which focuses storm flow and has created a trench-like channel in the basement clay horizon. The loose sediment shown in 2011 suggests a temporary bed level that high storm flows can shift further downstream. Thus the photo point comparison does not indicate whether the consolidated clay bed of the channel has been deepened. At the time the bed slope survey was done, a steel spike was used to probe the depth of loose sediment above the consolidated clay bed. The average depth near photo point 01 was 0.2 - 0.3 meters. In hindsight, re-assessment of the depth of loose sediment may have been a useful measure. Thus loose sediment depths taken along the rehabilitation reach may provide a better method for assessing sedimentation outcomes in reaches that have a firm base of clay or rock.

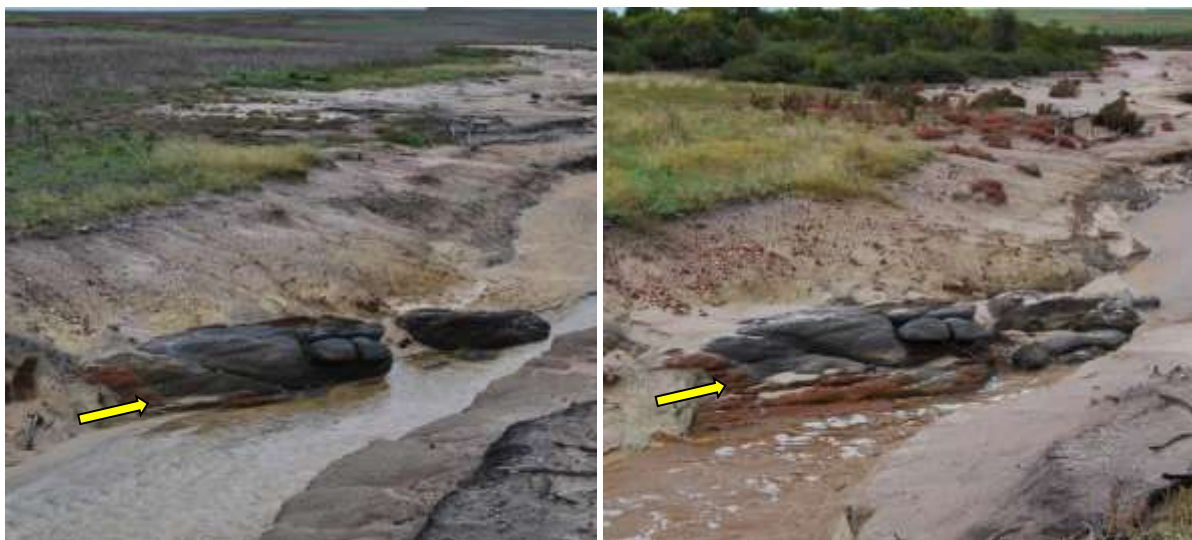
**Figure 11: Photo point 06. 28<sup>th</sup> February 2011 and 10<sup>th</sup> June 2016. Note the channel deepening and exposure of more of the rock bar.**

The situation at site 06, above, is similar to that discussed for photo point 01. Loose sediment depths taken a short distance upstream in 2011, , were 0.15 - 0.3 meters. It can be noted that the existence of solid basement rock extending across a channel can naturally provide a check on bed deepening proceeding upstream.

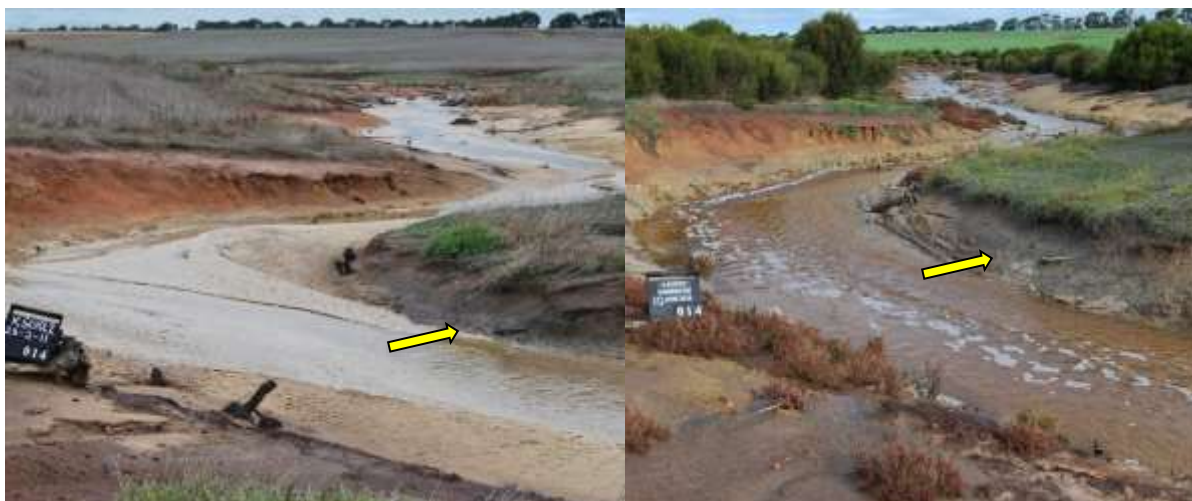
**Figure 12: Photo point 14. 28<sup>th</sup> February 2011 and 10<sup>th</sup> June 2016. Note, the channel sediment has been carried downstream with the exposed root on the right bank now well above the water level.**

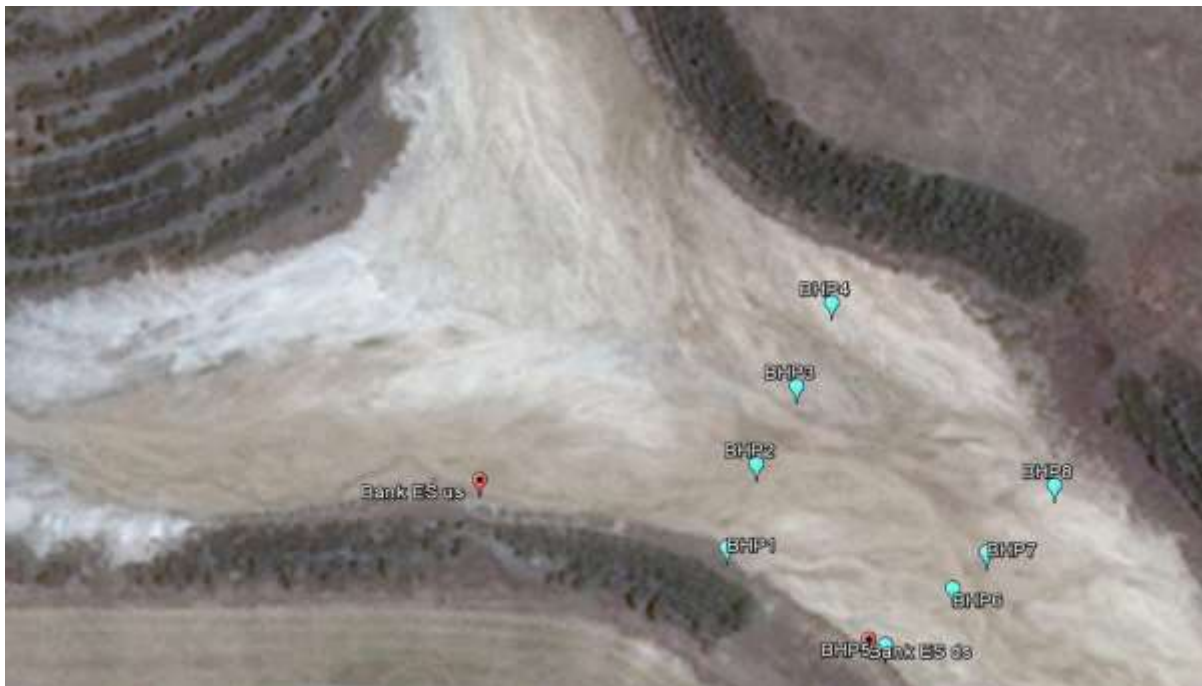
Eight stakes had also been placed in 2 rows of 4 across the large sediment plume shown at photo point 08 (Figure 14). The height of 6 of these stakes was measured to determine if the central area of the plume had changed in the five-year period. Two end stakes (No 1 and No 5) were omitted being in the middle of a narrow flow path at the time of assessment. All 6 stakes showed an increased depth of sediment varying from 15 to 175 mm with an average increase of 93 mm.

**Figure 14: Location of the stakes in the channel downstream of the tributary confluence.**

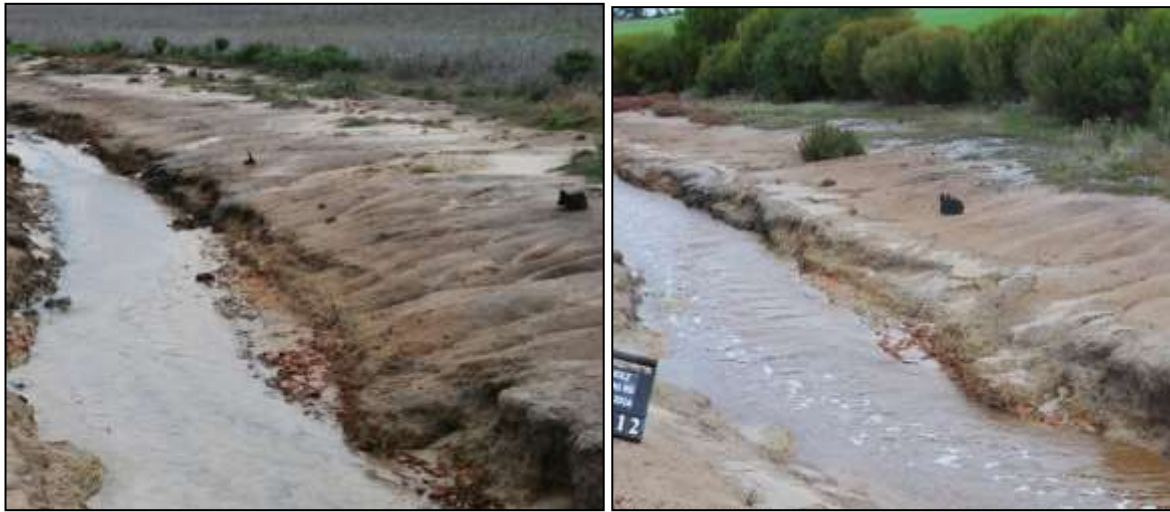
Any apparent increase in sediment deposition at other sites appeared to be relatively minor. For example, as shown at photo point 12 in Figure 15.

**Figure 15: Photo point 12. 28<sup>th</sup> February 2011 and 10<sup>th</sup> June 2016. Note that there seems to be some sediment deposition since 2011.**

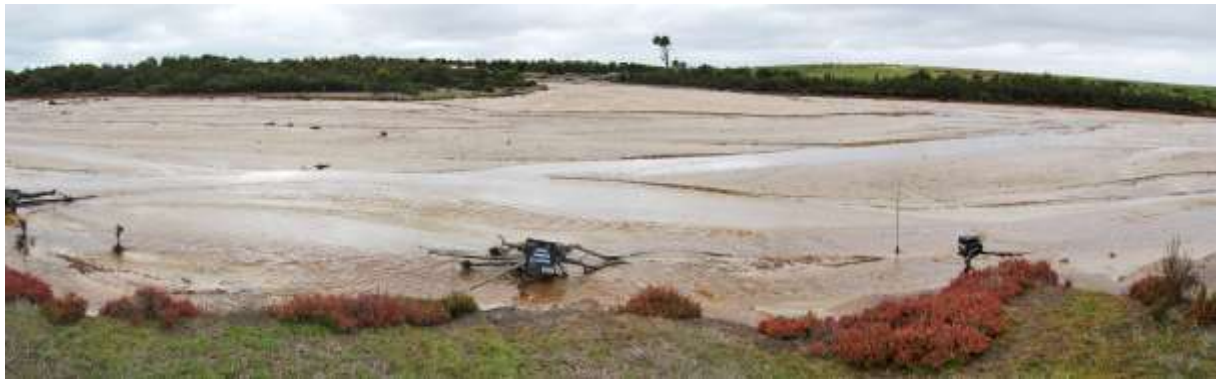
**Figure 16: View across the sediment plume at Photo point 08, 10<sup>th</sup> June 2016 showing large amounts of sediment coming from a relatively small salt scalded area to the north. The stake array is to the right of the view shown in the photo.**

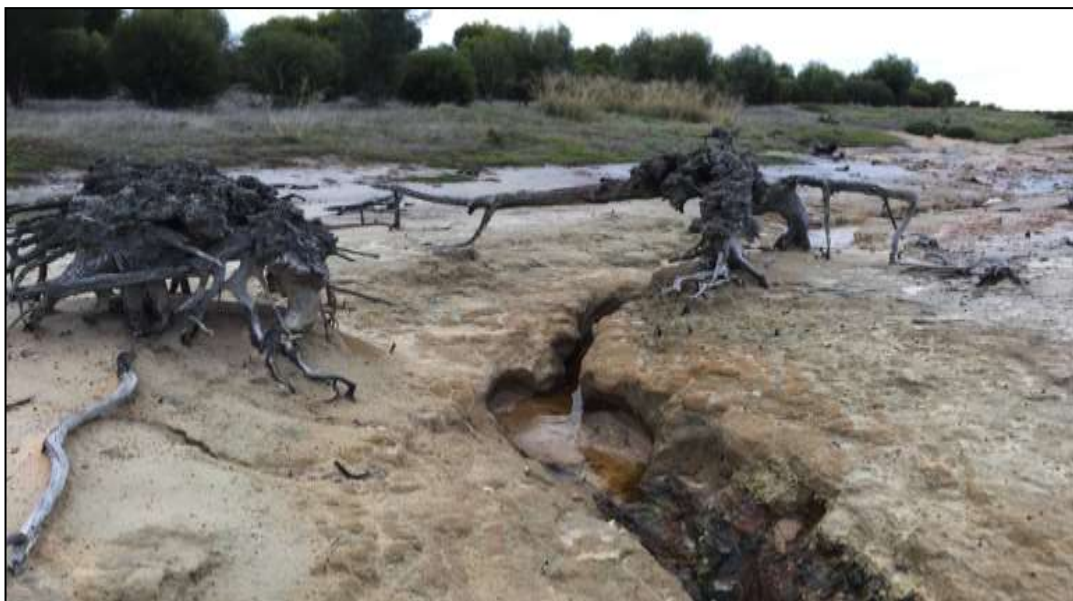
**Figure 17: Exposed Mallee roots show the amount of topsoil removed along the flow path towards the top end of the salt scald. The verge has been revegetated and grasses are moving into the bare areas.**

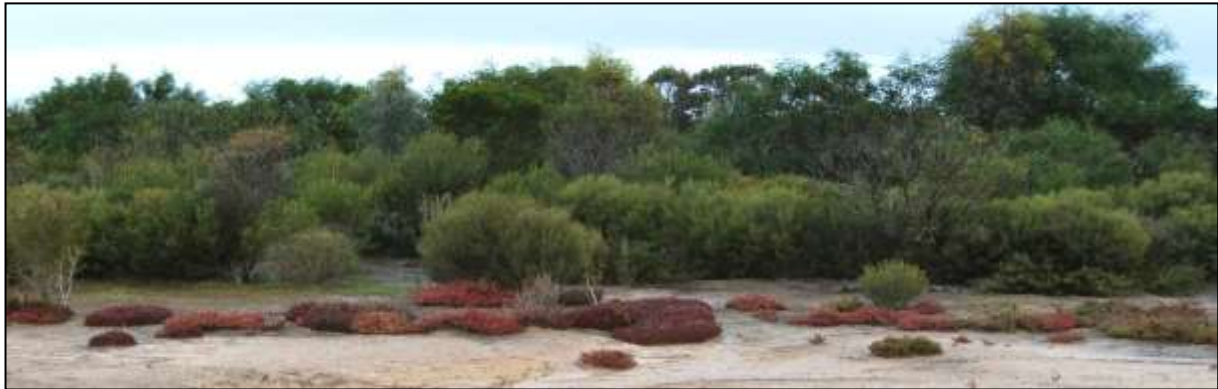
Figure 21: The western (right) bank at transect 1. This area had been direct seeded.

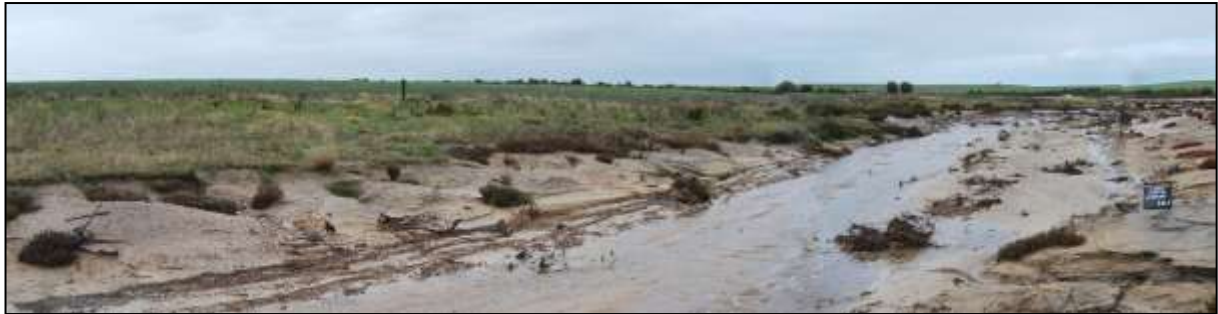
Figure 22: The eastern (left) bank at transect 1 (2016). This area had not been revegetated however, after fencing and stock exclusion, there has been some regeneration of Samphire and Rhagodia plants among the pasture grasses and weeds.

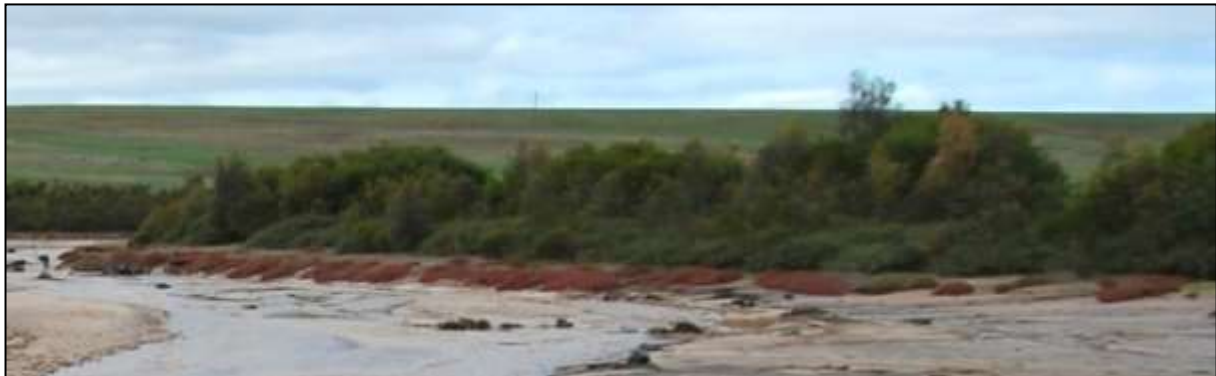
Figure 24: The southern (right) bank at transect 2. This area had been direct seeded.

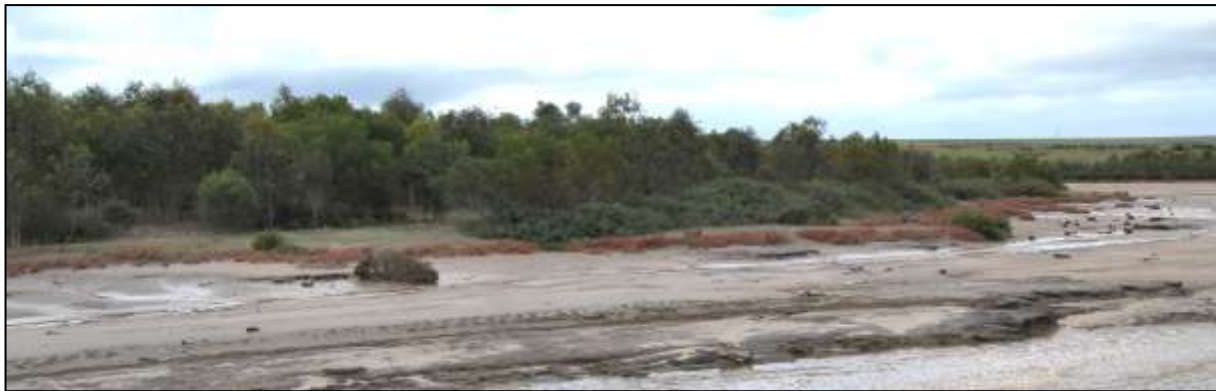
Figure 25: The northern (left) bank at transect 2. This area had been direct seeded however the seeding furrows are fairly wide apart and in many places the trees and shrubs are less than 30 cms apart (i.e. it seems to have been densely sown.).

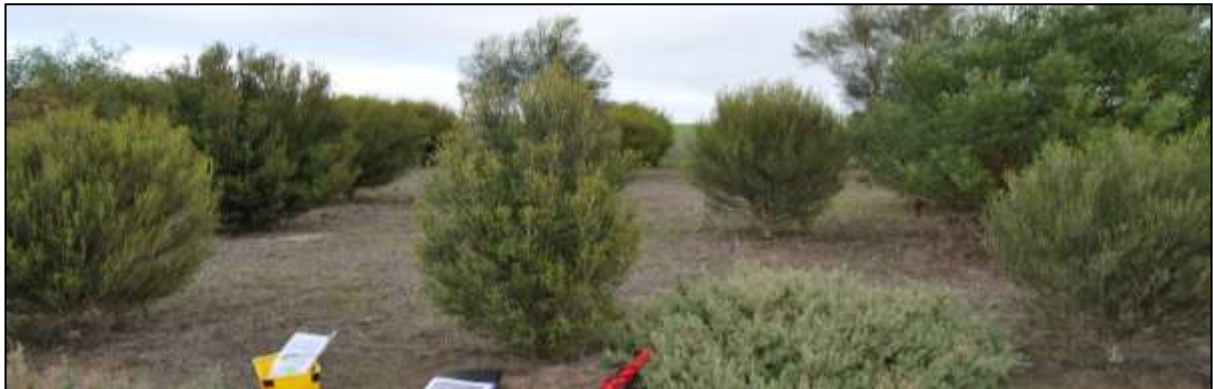
The left (western) bank which was planted with seedlings shows the decreased density of planting and reduced number of species when compared to the direct seeded area on the right (eastern) bank.

Figure 27: The western (right) bank at transect 3. This area had been planted with seedlings.

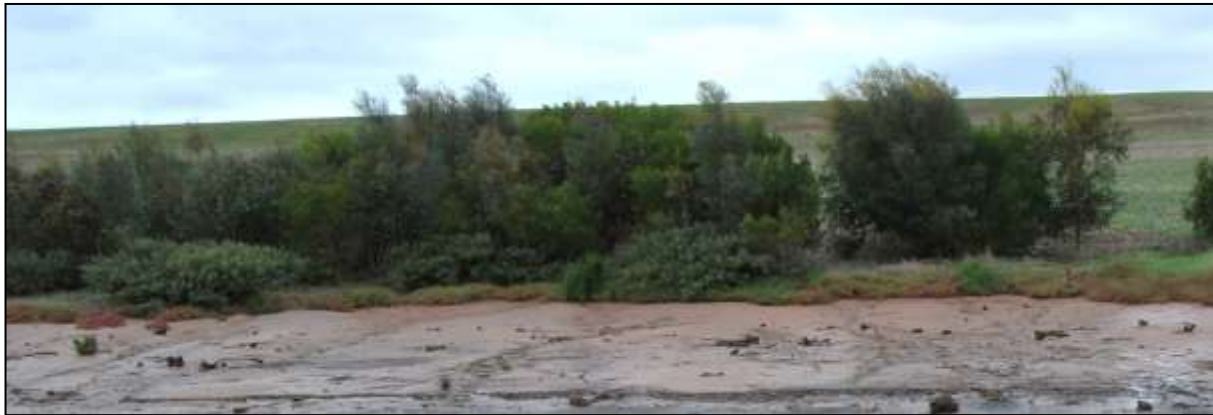
Figure 28: The eastern (left) bank at transect 3. The transect was near the end of the direct seeded area (in the left of the photograph). Further downstream the left bank was planted with seedlings only.

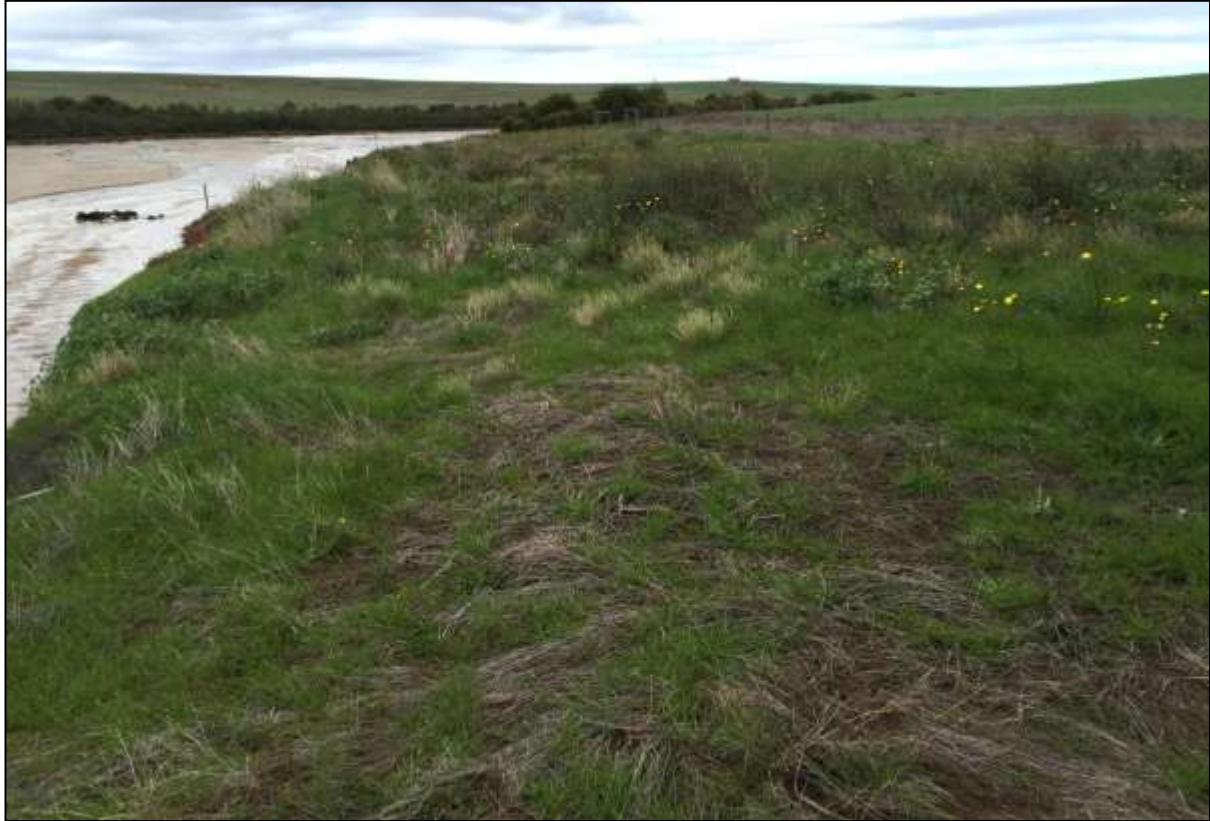
An 80 metre section of the right hand bank between PP08 and PP09, was not planted at all in order to see what plants would recolonise the verge area unassisted. No assessment was undertaken of the vegetation in 2016 however it can be seen to be dominated by pasture grasses which also act to stabilise the soil surface.

**Figure 29: Un-revegetated section of the right hand bank.**
