# **Warperup Creek Improvement Plan Feasibility Study 2022**

**Prepared for  
North Stirlings Pallinup Natural Resources Inc  
by Steve & Geraldine Janicke**

Prepared by Geraldine and Steve Janicke for North Stirlings Pallinup Natural Resources Inc as part of the Waterways Restoration Project (CSGL19013).

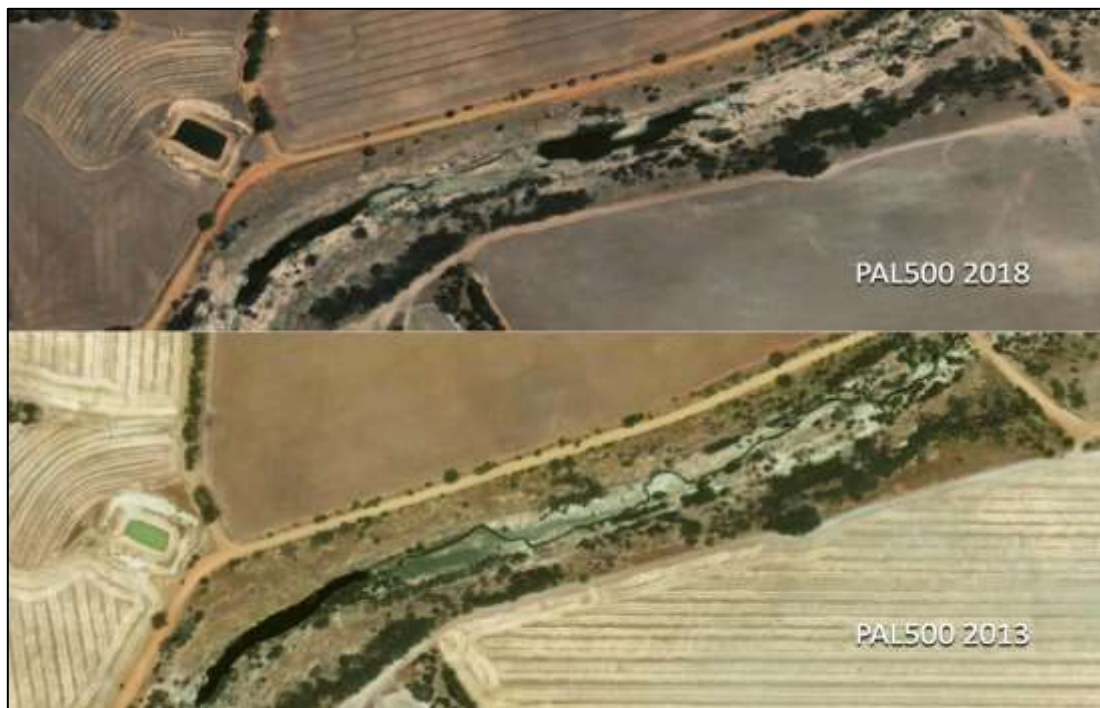
Figure 1: Google Earth imagery showing the movement of large sediment slugs along a lower reach of Warperup Creek in 2018 and 2013.

Warperup Creek appeared to discharge a substantial amount of sediment during the 2017 flood, suggesting that mobilisation of existing sediment in the floodway, ongoing bank erosion or both, were still active processes. Figure 1 below shows large sediment slugs in the lower reaches of Warperup Creek. The differences over a five-year period give some idea of the active conditions in the floodway. The fragmented nature of the riparian vegetation, which is a common and obvious feature of the catchment waterways, can also be seen.

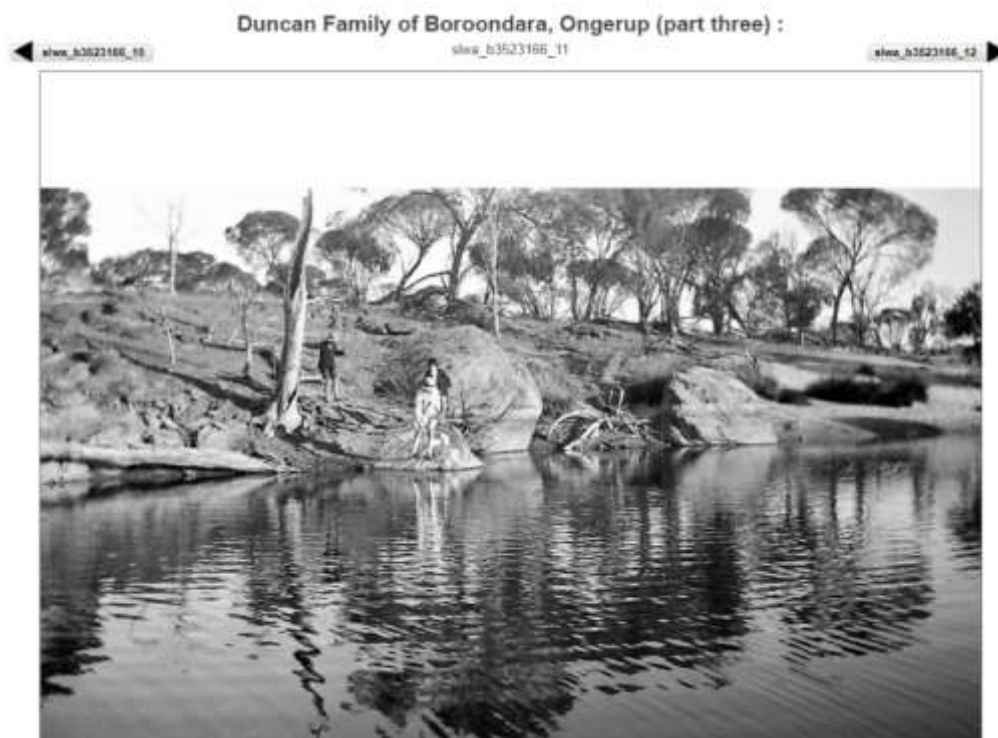
**Figure 6: A photo taken in 1930s<sup>3</sup> at site PAL507 on Warperup Creek showing the bank denuded by stock access.**

Several photographs of farming family activities, farm views and floods from the 1930s through to the 1950s were located during the literature review (i.e., Figure 6 above). These have provided some idea of the condition of the Warperup waterways in those times.

The presence of bare banks, washouts and sediment plumes imply that the condition of the floodway had already been significantly impacted by stock denuding the bed and banks and increased storm runoff. Current observations suggest there has been some recovery in areas, and this may reflect changing land management practices, particularly the transition to cropping and reduced grazing pressure. The waterways appear to have entered a new equilibrium phase.

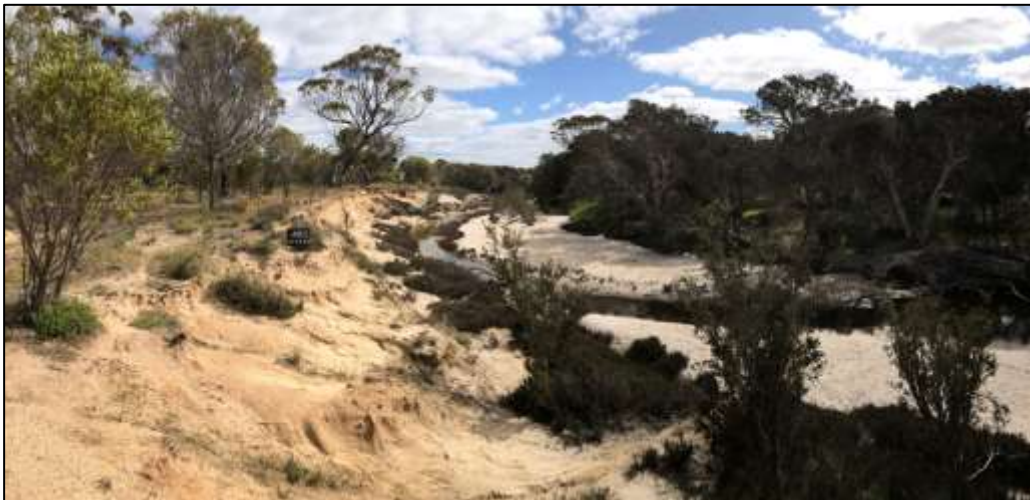
**Figure 8: Typical features of the main channel of Warperup Creek are a relatively narrow floodway.**

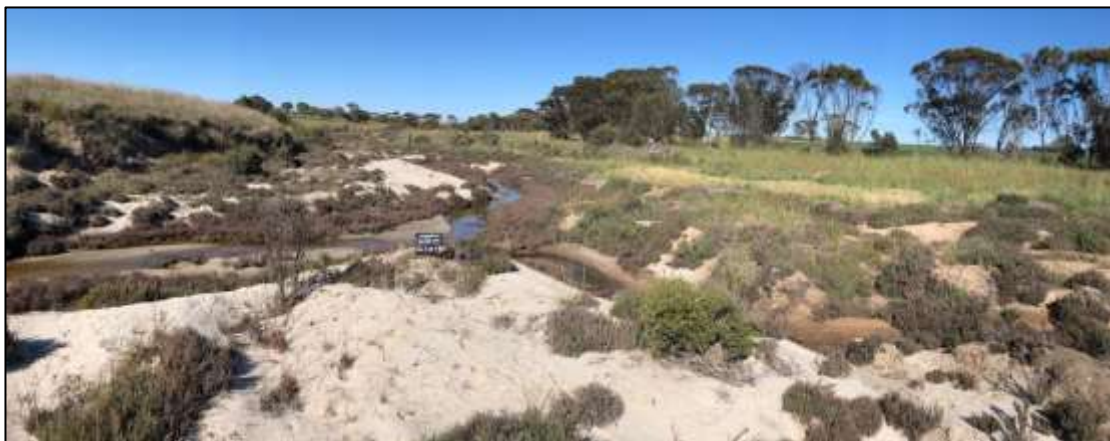
**Figure 9: Warperup Creek floodway showing extensive sand plumes, eroded banks, fragmented tree and shrub cover with grasses and Samphire dominating.**

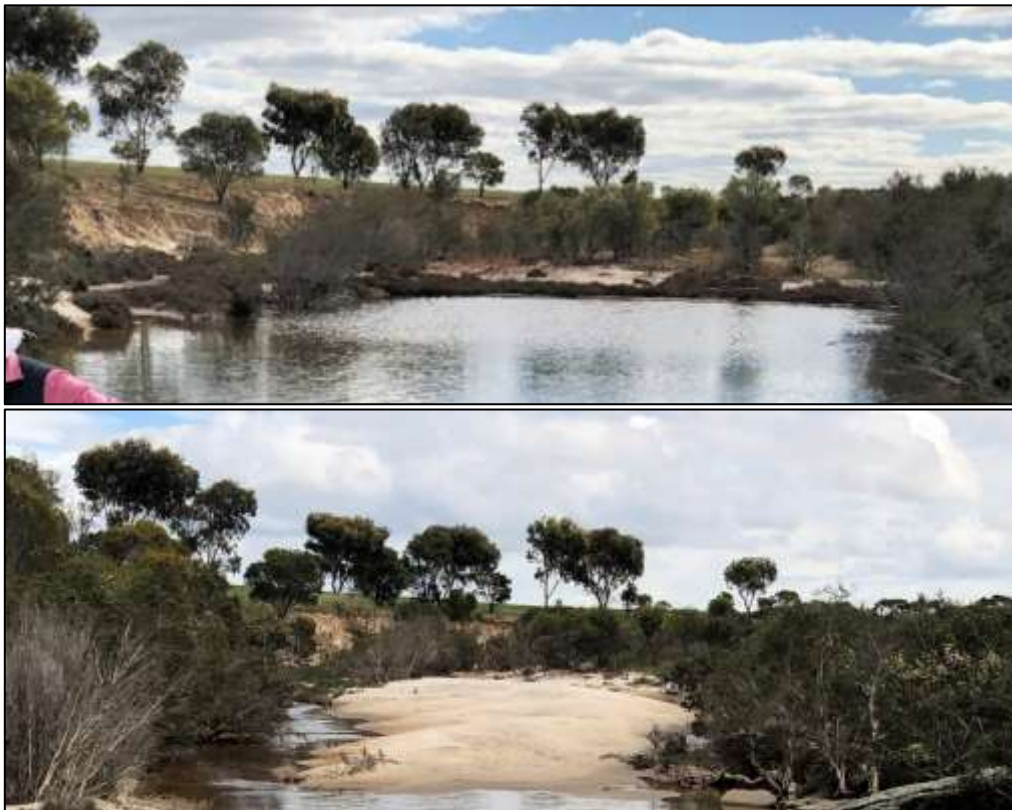
**Figure 23: Zoomed in to the end of the pool at Site PAL508 on Warperup Creek, 2020 and 2021. Although the photo in 2021 was from a slightly different angle, the extent of sediment deposition can be seen.**

Sediment at most Warperup reference sites has been very mobile with the 2021 high flow (one in ten-year flood) re-distributing large quantities of sand as seen in Figure 23 and Figure 24.

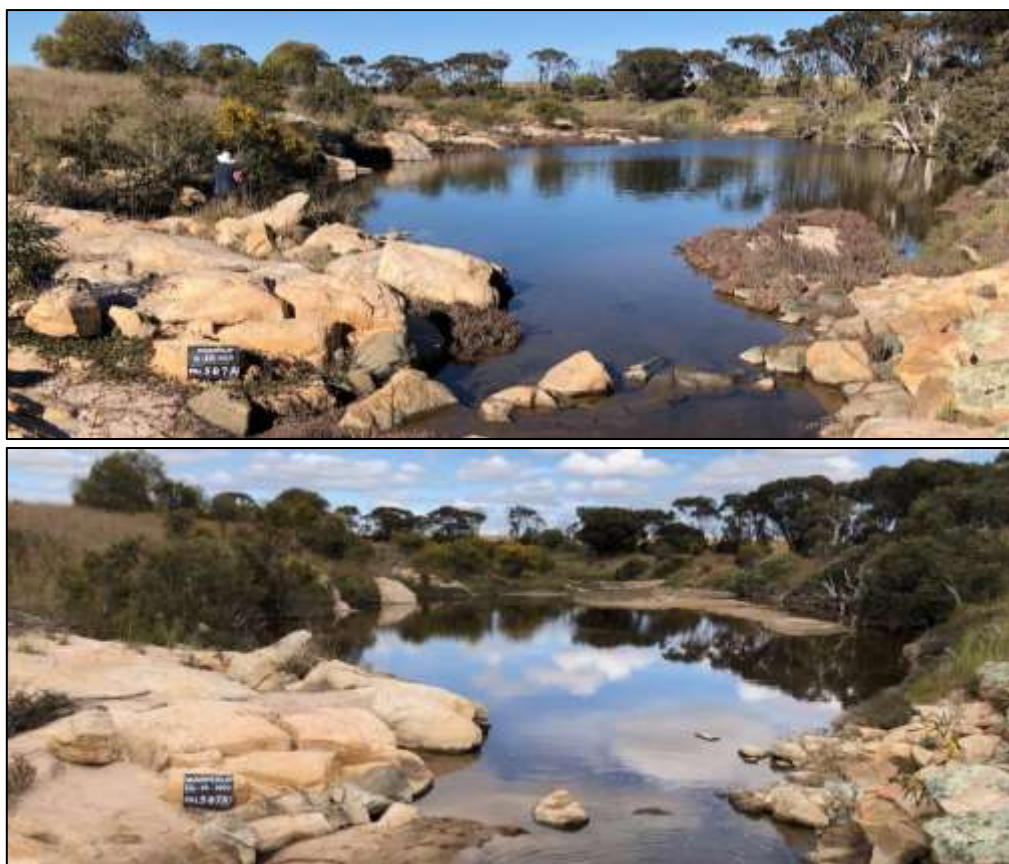
Figure 24: Sediment infilling of the pool at Site PAL507 on Warperup Creek in October 2020 and October 2022.

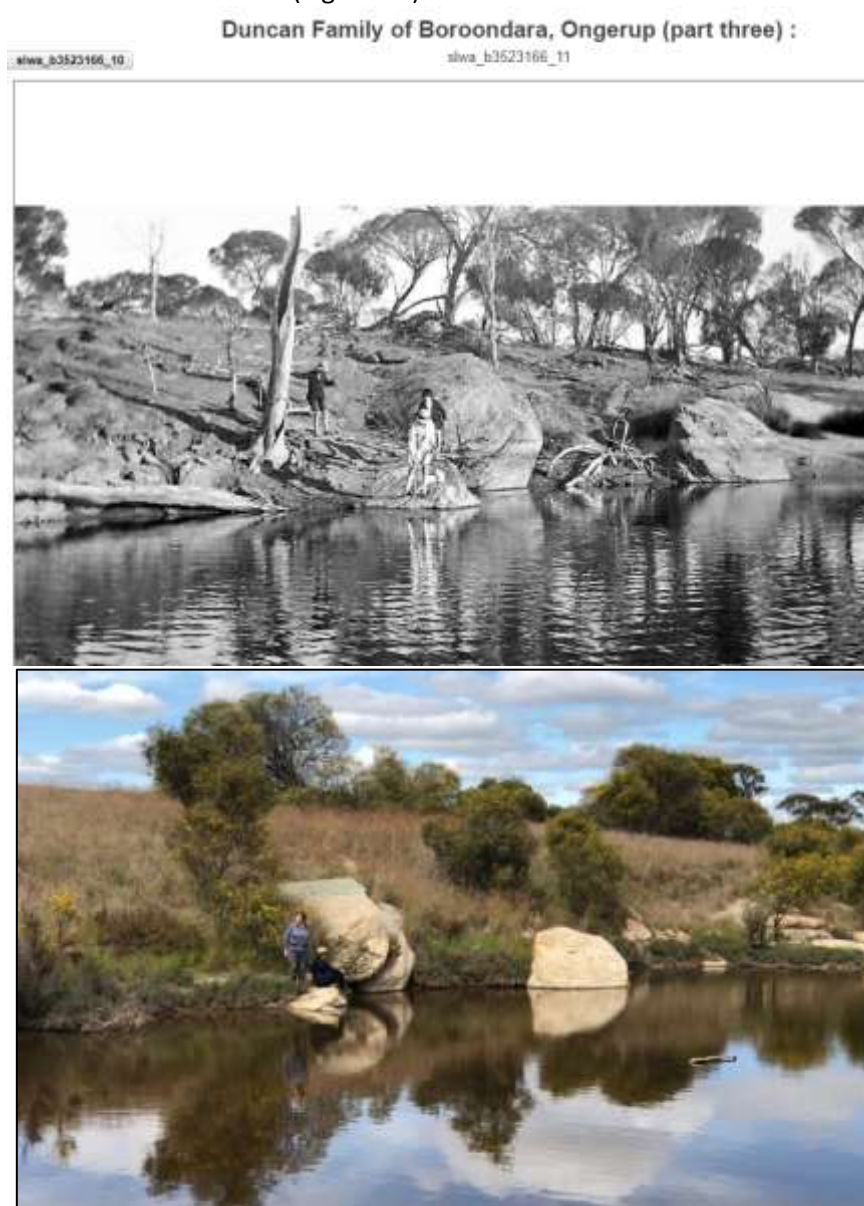
**Figure 25: 1930s<sup>7</sup> image of Duncan family of Boroondara (State Library of WA) and the same location October 2022**

A review of several historic images of Warperup Creek provides some evidence that from the time of clearing until the 1950s, the riparian zone was increasingly denuded of all but occasional trees. This was largely due to stock having unrestricted access to the streams, combined with floods, periods of drought and perhaps wildfires. One historic image coincided with monitoring site PAL507 and could be compared with conditions in 2022 (Figure 25).

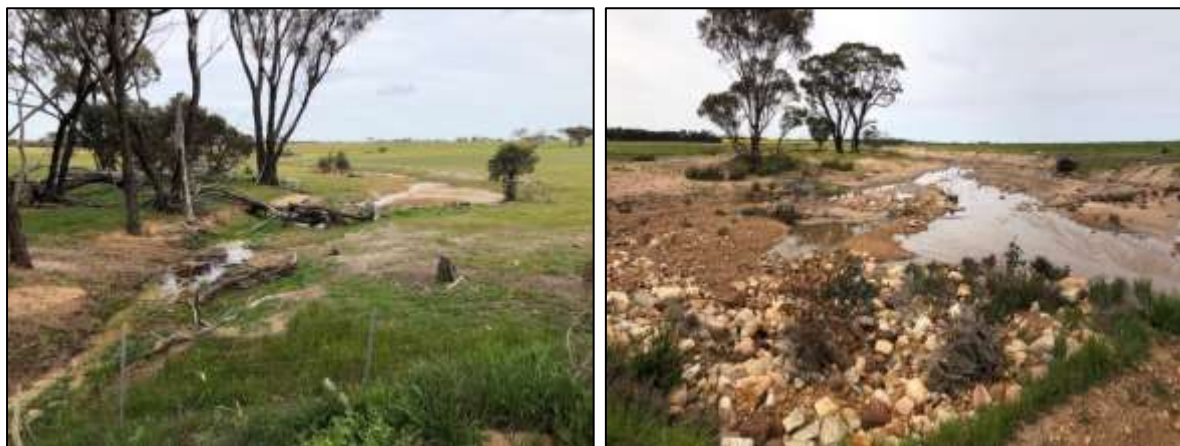
Figure 29: Left: A second order tributary to the Peerup-Meenup Creek. Right: Allen Creek, a fourth order stream. Both would benefit with localised revegetation to minimise channel erosion.

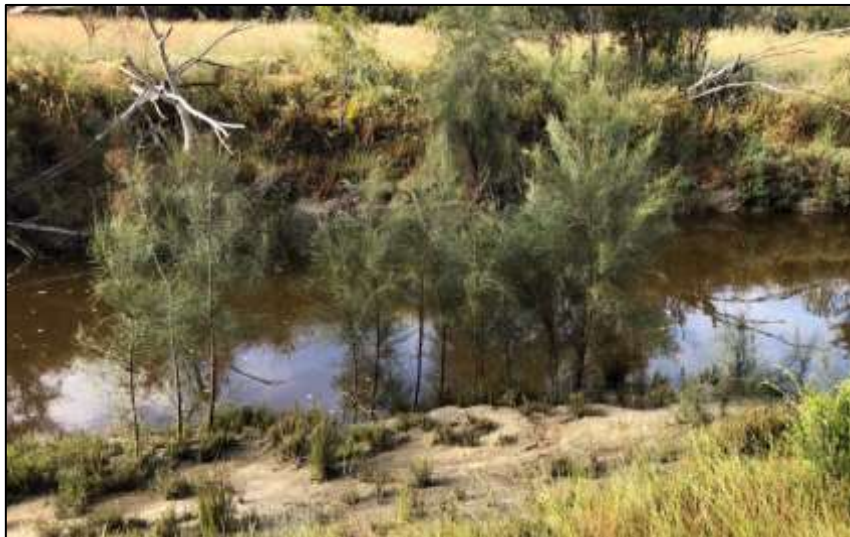
**Figure 30:** At this site near Borden, Sheoak have naturally seeded onto clay-based erosion scours, aided by a thin layer of sediment.

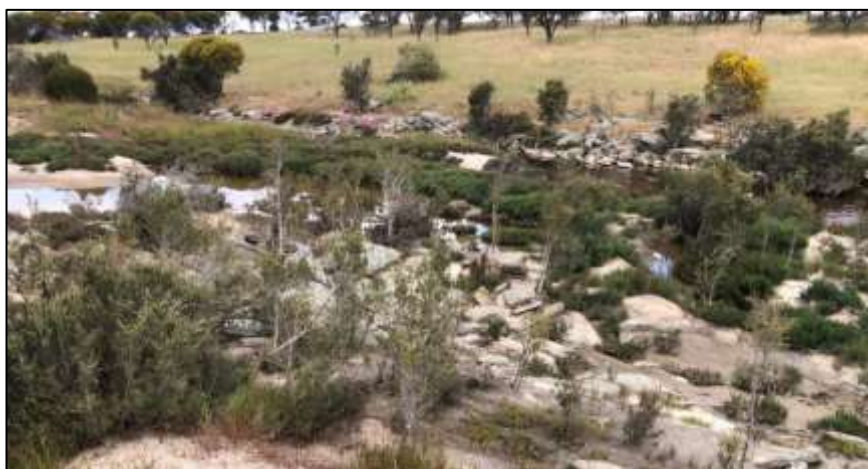
**Figure 31:** Warperup main channel downstream of Hart Road with Salt-water paperbarks (*Melaleuca cuticularis*) colonising the active channel. Other locations may just need a bit of help.

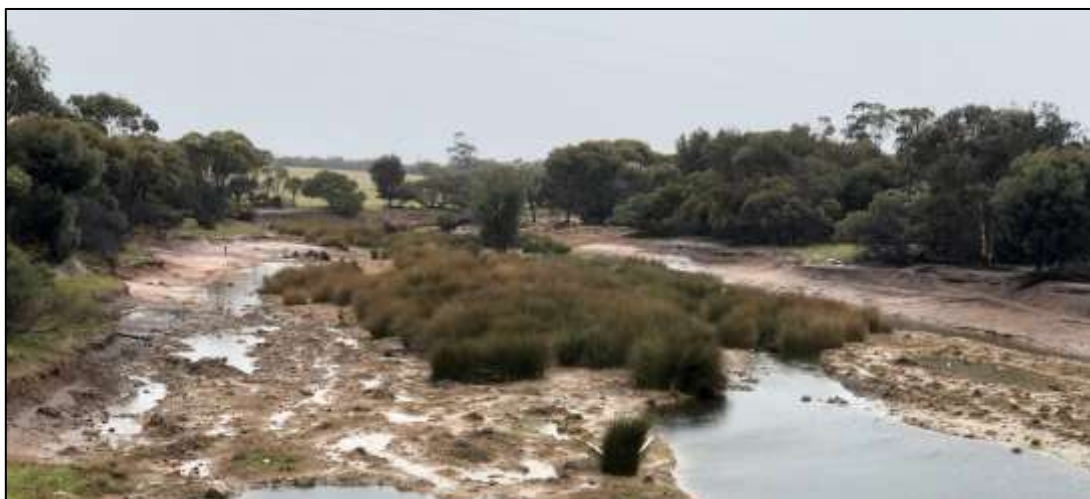
Figure 32 : Gnowangerup Creek revegetation site with Sea Rush (*Juncus kraussii*) colonising the bed.

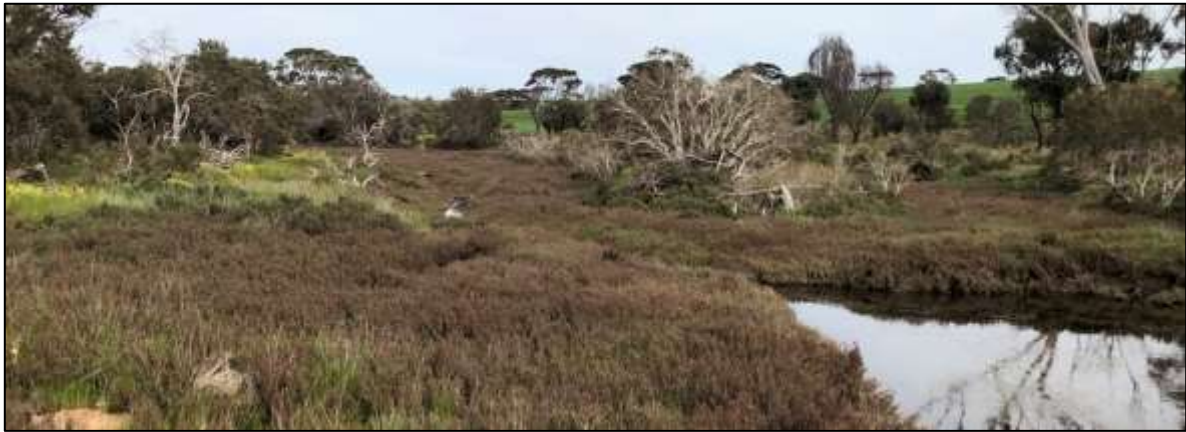
Figure 33: Dense Samphire colonisation along a reach of Coromup Creek (stream order 4).

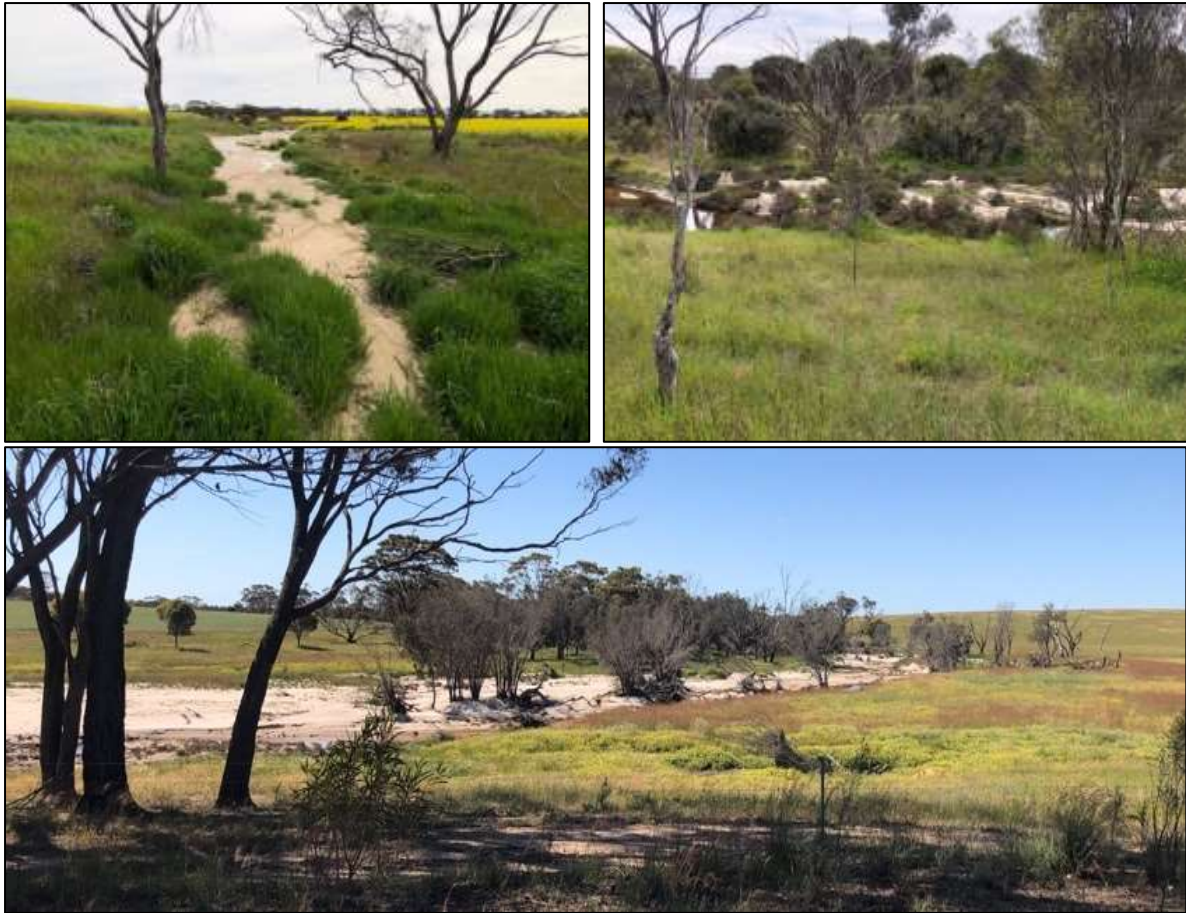
**Figure 34: Sediment deposition in a number of waterways in the Warperup catchment. Top left: A 1st order tributary to Peerup Meenup Creek. Top right: A 3rd order section of Ongerup Creek. Lower image: A 6th order section of the Lower Warperup Creek.**

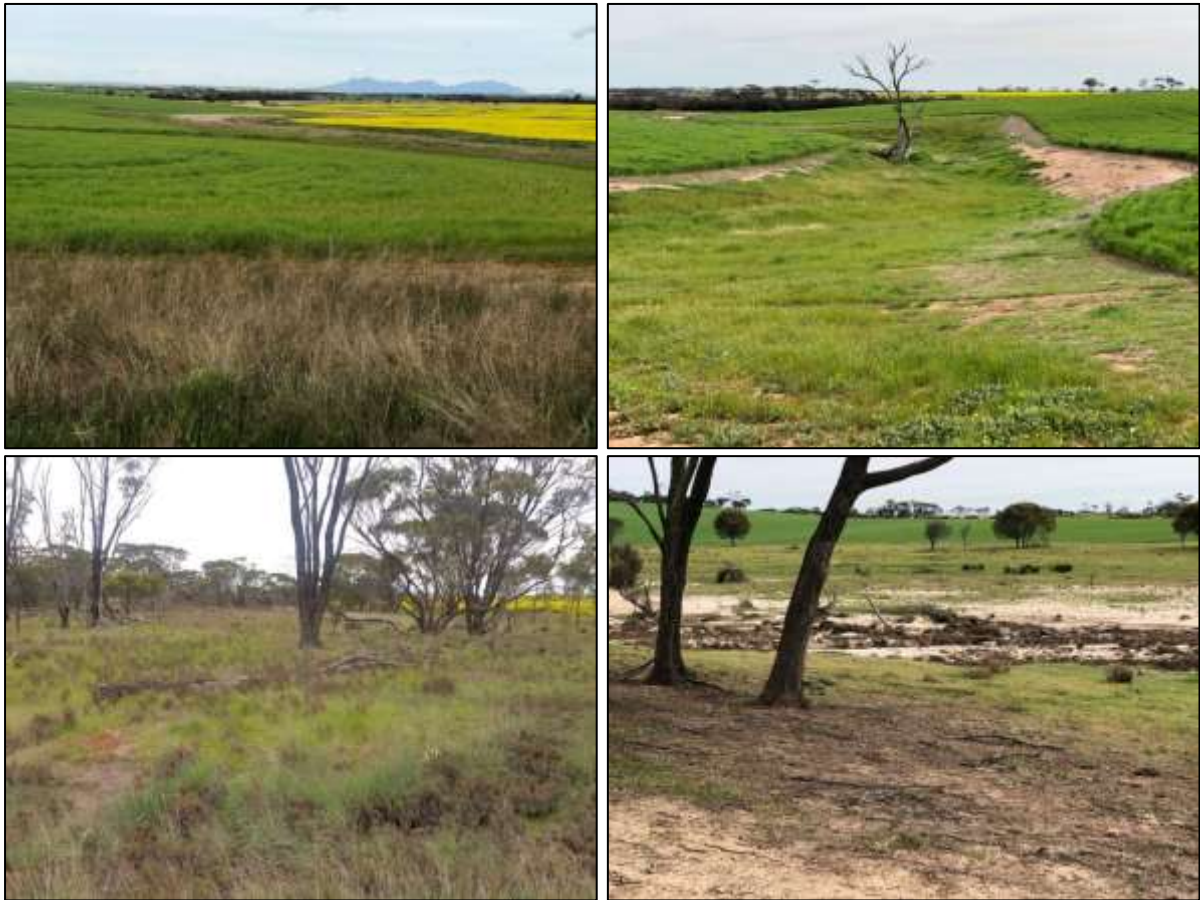
**Figure 36: Examples of reaches lacking riparian habitat diversity. Top Left: First order tributary to the Peerup-Meenup Creek. Top Right: 2nd order tributary to Lower Warperup Creek. Lower left: Ongerup Creek, 2<sup>nd</sup> order. Lower right: Lower Warperup Creek, 6<sup>th</sup> order waterway.**

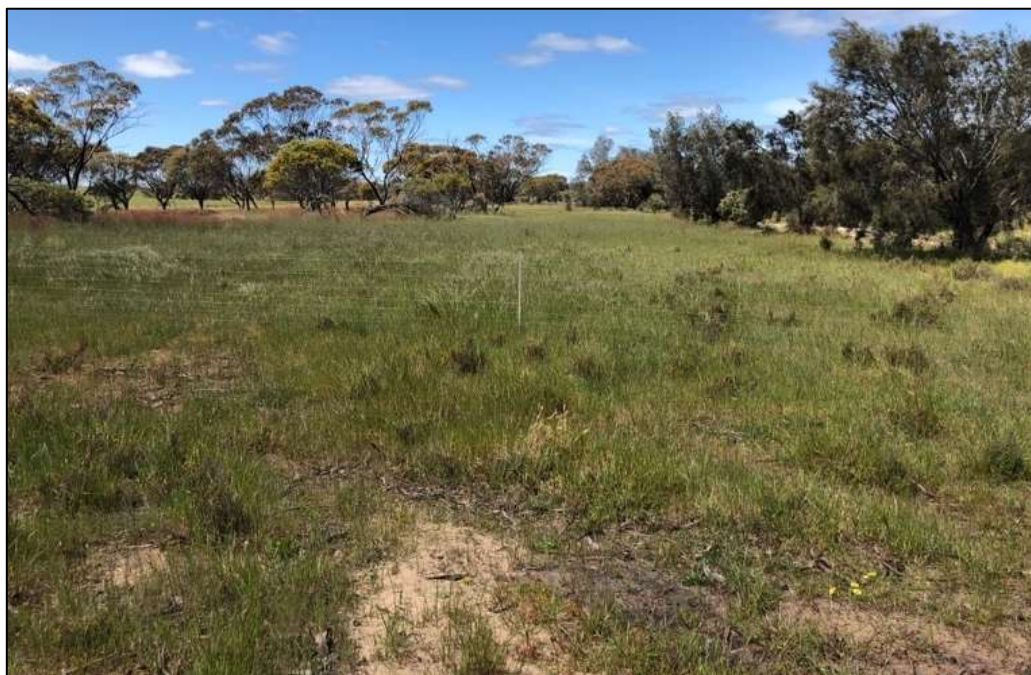
**Figure 37: A broad uncultivated area adjacent to a creek that is a potential carbon farming site.**

The early adopters of carbon farming will likely consider it in a plantation or cropping sense. From the perspective of waterways rehabilitation and because vegetation is the engineering material of choice, consideration can be given to determining whether rehabilitation of riparian zones offers opportunities for increasing carbon farming income. However, a model for costing fragmented on-ground works would need to be developed. Areas which may provide benefits both ways are wide uncropped flats (as in Figure 37) and largely denuded flood prone areas adjacent to streams.

The benefit for waterways is that Increased tree cover can act to lessen flood power, reducing floodway erosion and encouraging the re-formation of deep river pools. Of course, these areas often set aside for stock management purposes.

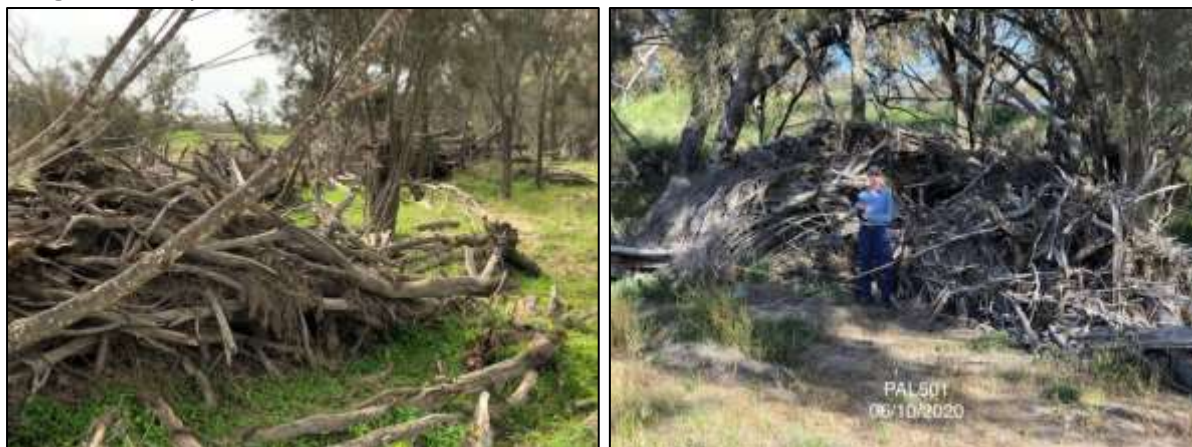
**Figure 38: Snag piles along the lower Warperup Creek**

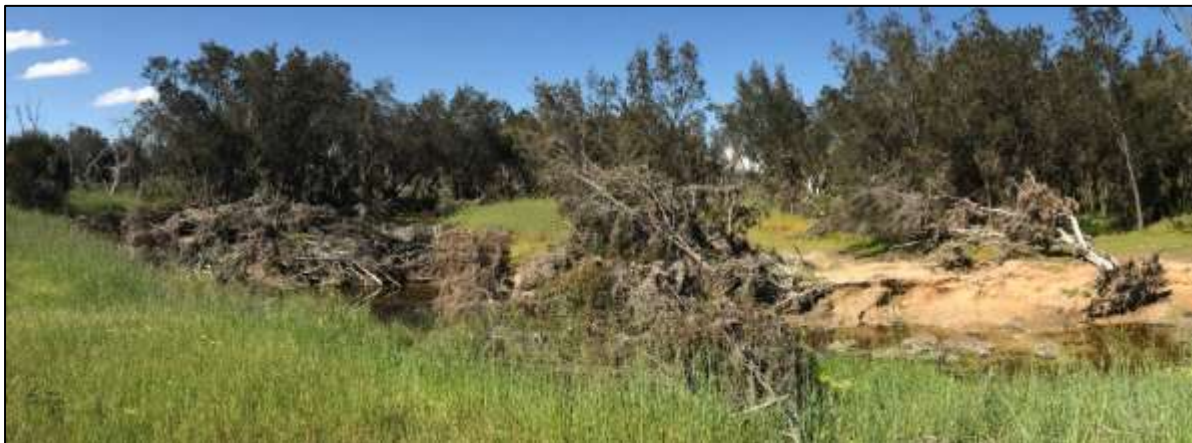
**Figure 39: Debris piles, including newly fallen trees blocking the active channel on the Middle Pallinup following the 2017 flood.**

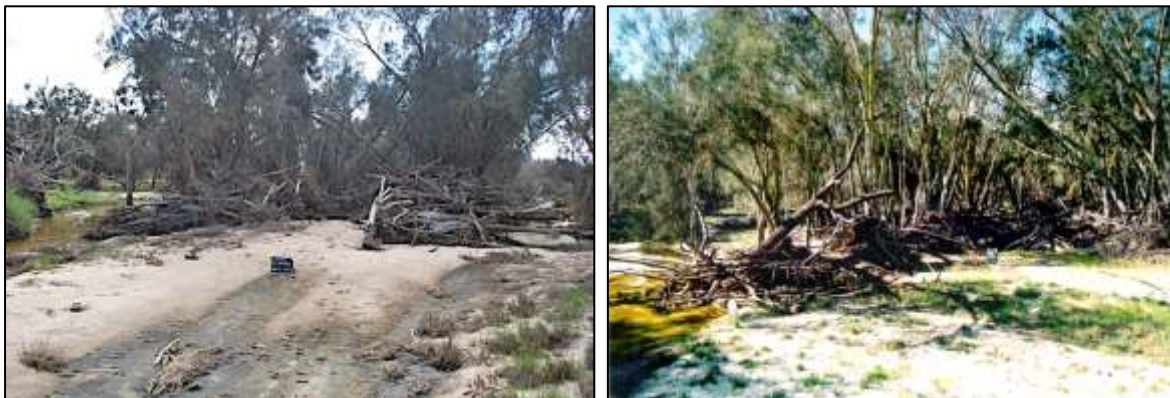
**Figure 40: The snag pile shown above in 2001 (Right) and increased in size (Left) after the 2017 flood. This has pushed the low flow channel further to the left side of the floodway.**
