# Warperup Creek Improvement Plant Feasibility Study 2022

## SUPPLEMENT 3 - Waterway condition assessment framework

Prepared for North Stirlings Pallinup Natural Resources Inc

November 2022

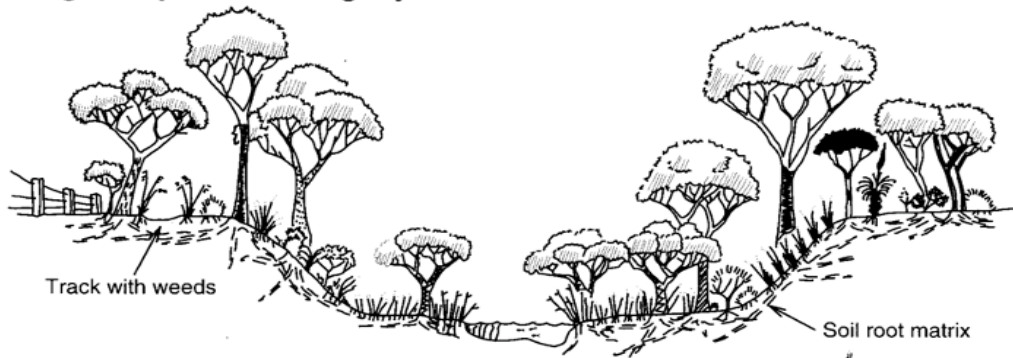
**A grade: pristine to slightly disturbed**

: Pictorial representation of the Pen-Scott four basic foreshore condition grades

Stream reaches are graded on a simple A - B - C - D scale, A being pristine (A) and D being highly degraded. There are also three degrees within each grade, for example B1 – B2 – B3. The process of degradation is rated by considering the relative levels of native plants and weeds, their health and the degree of soil disturbance. B Grade corresponds to a situation where native plant species and exotic weeds are both common and bed and bank erosion arising from external pressures is starting to compromise the integrity and resilience of the riparian ecosystem. Once degraded to B, C and D categories, streams will not be returned to A1 grade given the change of stream flow pattern due to land clearing, the proliferation of weeds, feral animals, and other irreversible disturbance factors. Nevertheless, improvements to stream condition would ideally halt and reverse various degrading processes and the floodway would move from D grade to C grade and possibly to B grade.

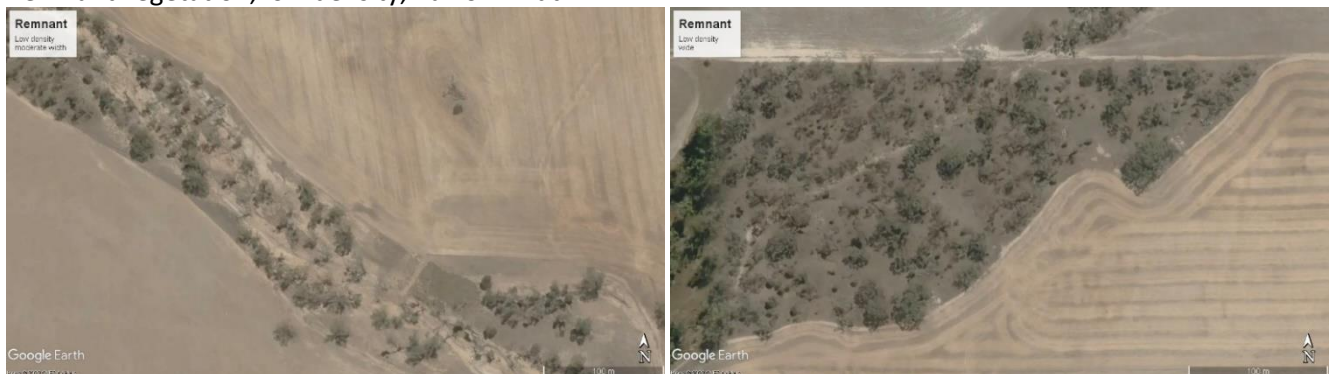
Remnant vegetation, low density, moderate width, and low density, wide.

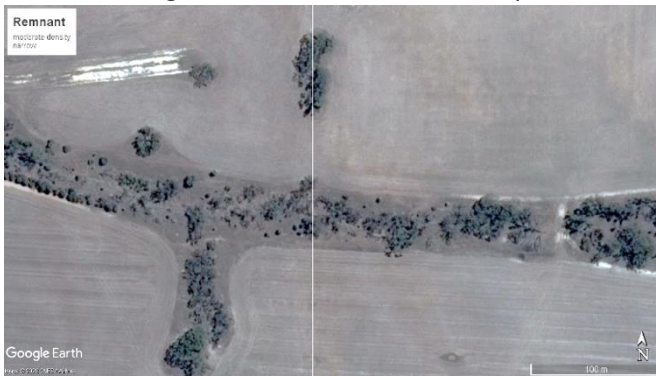
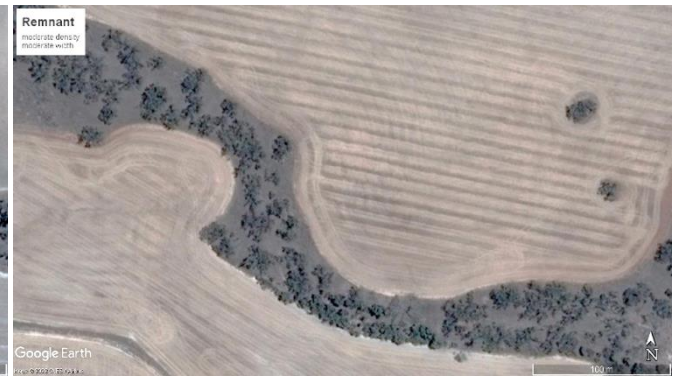
Remnant vegetation moderate density, narrow and

moderate density, moderate width

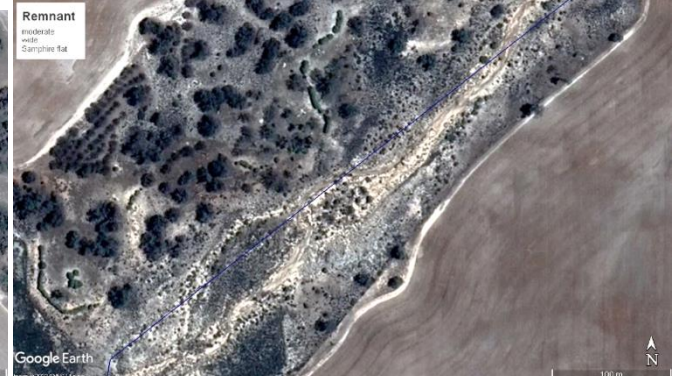
Remnant vegetation moderate density, moderate width and moderate density, wide. Note some revegetation apparent, and Samphire increasing density of cover.

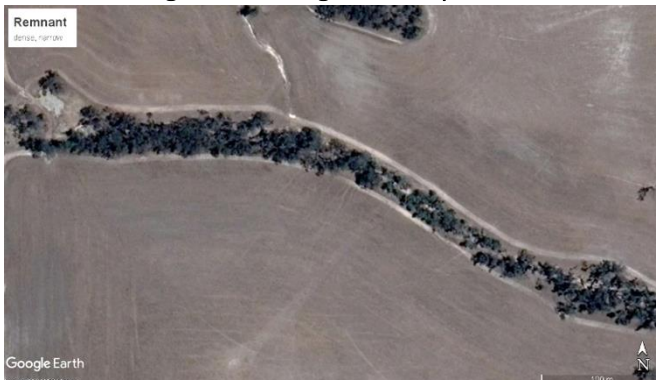
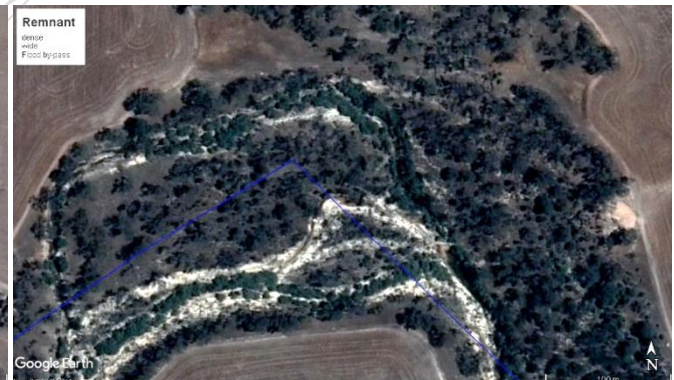
Remnant vegetation, high density, narrow and lines of Sheoak trees.

high density, wide. Note the flood bypass with

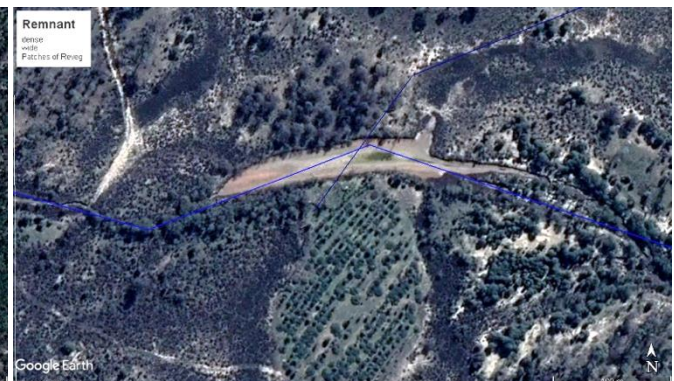
Remnant vegetation, high density, wide and

high density, wide with a patch of revegetation.

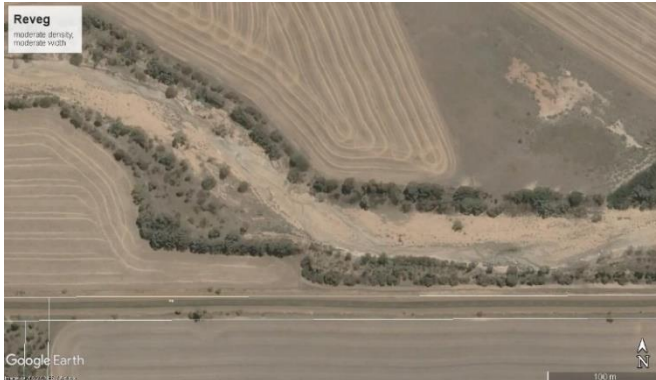
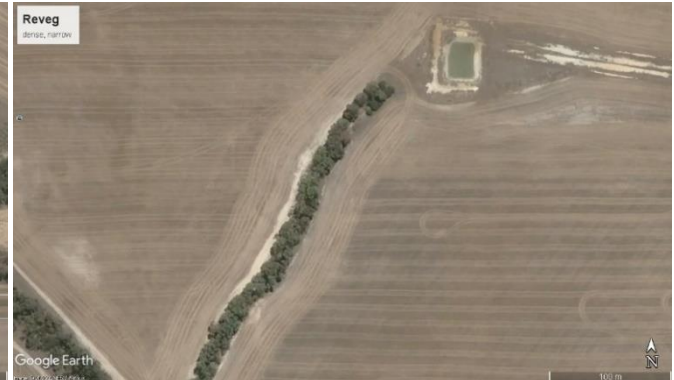
Revegetated, moderate density, moderate width and

dense, narrow

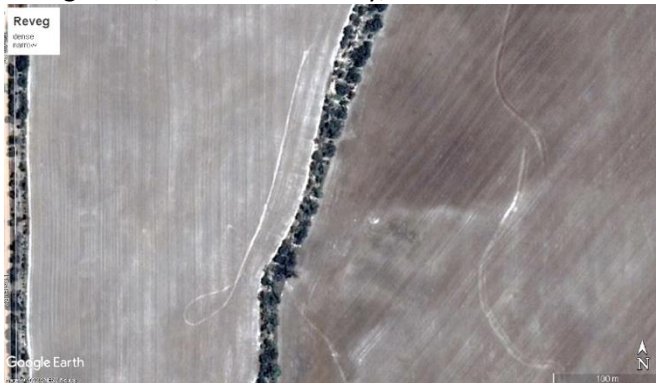
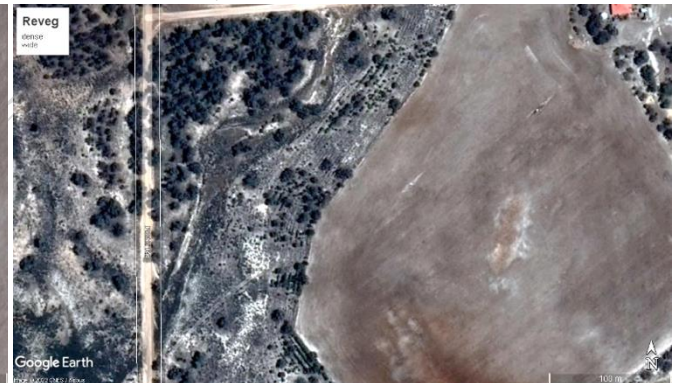
Revegetated, dense, narrow and vegetation.

dense, wide with patches of remnant
