# Warperup Creek Water Condition Monitoring

## Supplement 4 - Results for 2020 to 2022

Prepared for North Stirlings Pallinup Natural Resources Inc.

**November 2022**

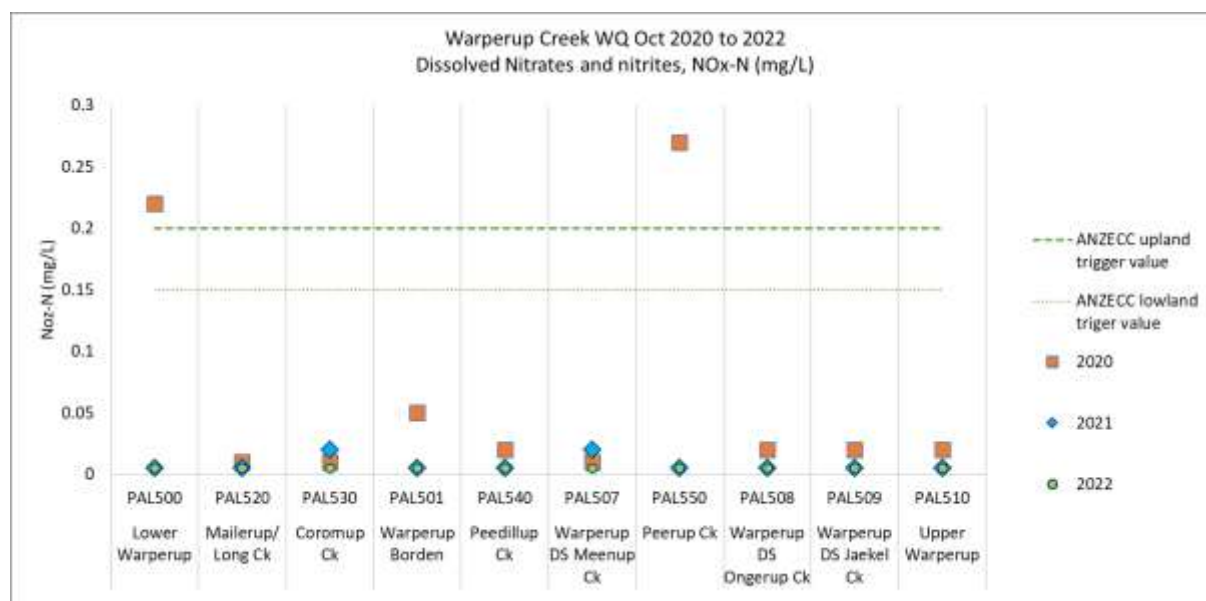
Figure 12: Nitrate and nitrite N (mg/L) in water samples collected from Warperup Creek and tributaries, October 2020 to 2022 and the ANZECC trigger guidelines<sup>2</sup>.

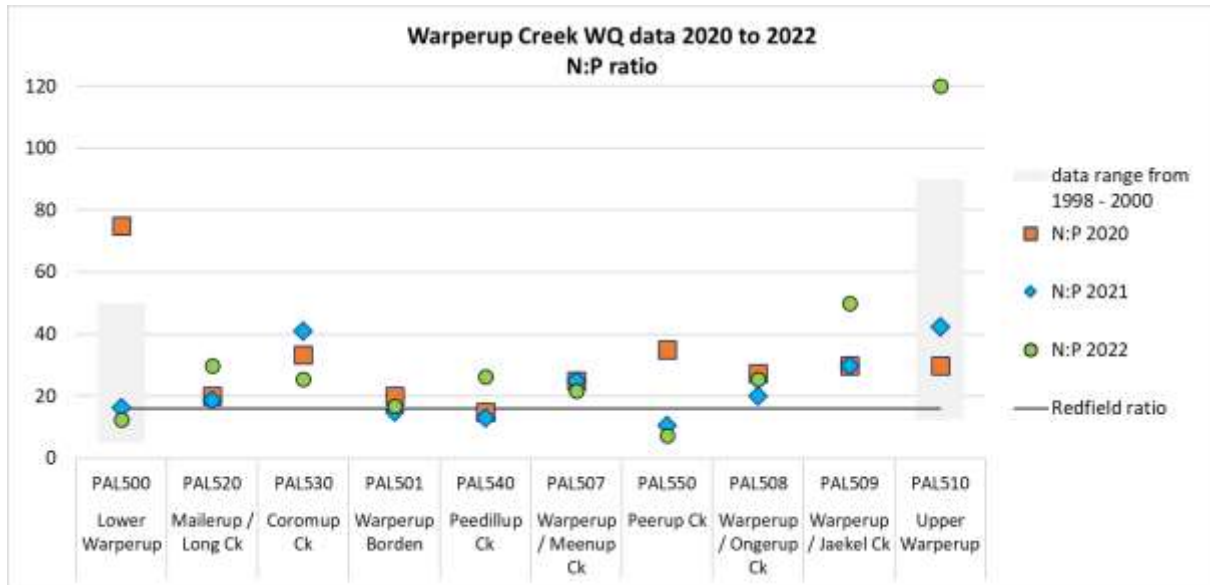
The variation in nutrient values suggests that seasonal sampling for both Nitrogen and Phosphorus concentrations is necessary to provide a clearer picture of potential nutrient impacts in the waterways and how this relates to natural factors such as rainfall and temperature, but also the potential for riparian rehabilitation to moderate eutrophication risk.

Figure 16: The Total Nitrogen: Total Phosphorus ratio (TN:TP) in water samples collected from Warperup Creek and tributaries, October 2020 to 2022. The data range from sampling two sites between 1998 and 2000 is shown as a grey bar.

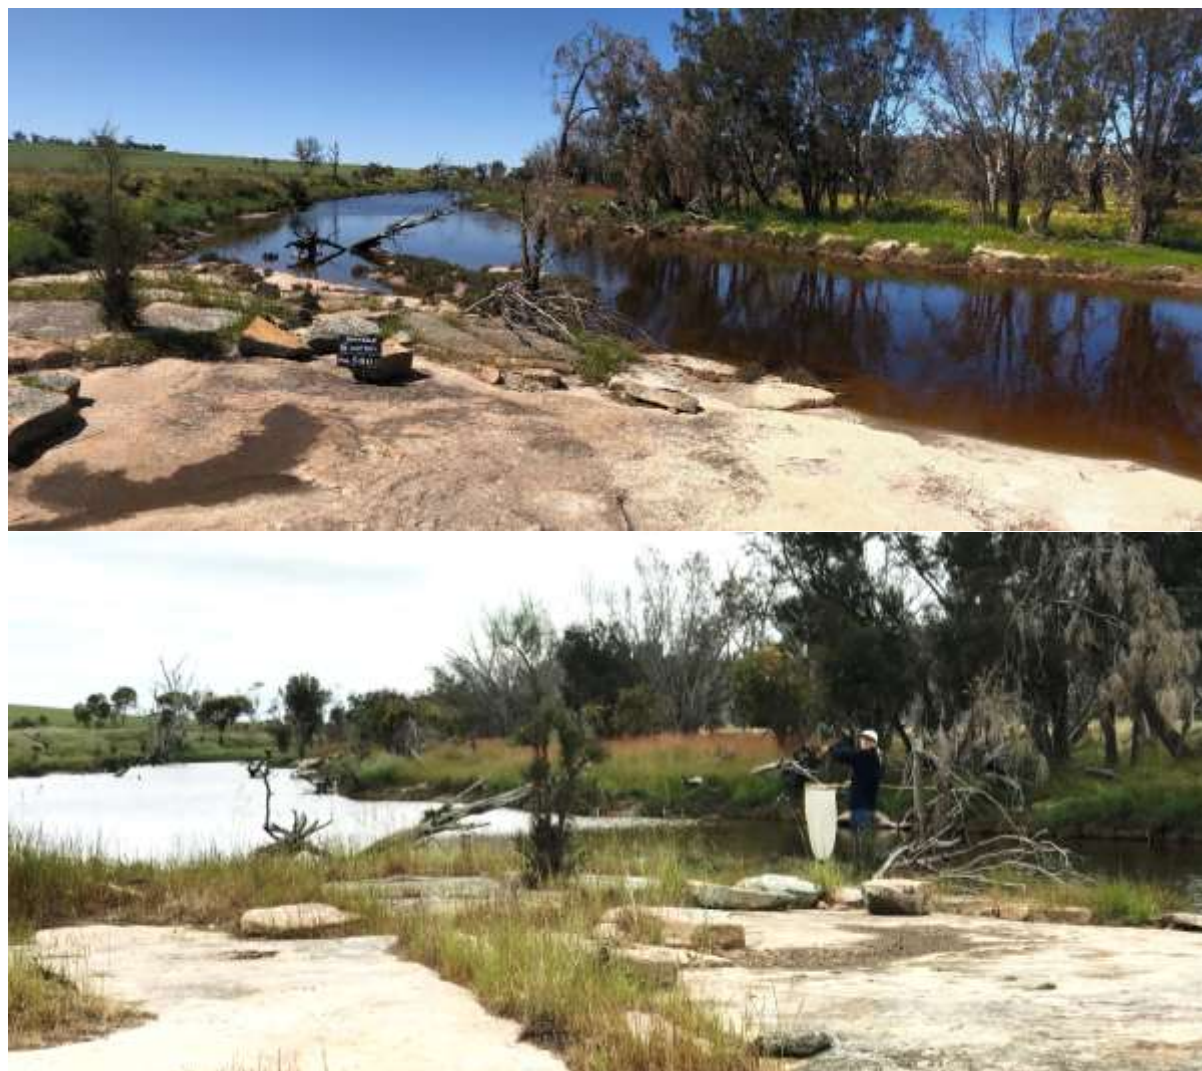
This reach is at the lower end of Warperup Creek on the south side of Maileerup Road and runs parallel to it. In the late 1990s the accuracy of GPS devices was poor accuracy and location coordinates could vary by up to several hundred meters at different times. This site was sampled in the days of the Waters and Rivers Commission (1998-2000), most probably at the Maileerup Road crossing near the top end of the reference reach rather than at the current site at the downstream end.

Figure 24: Sampling site PAL500, lower Warperup Creek on 6 October 2021 and 13 October 2020.

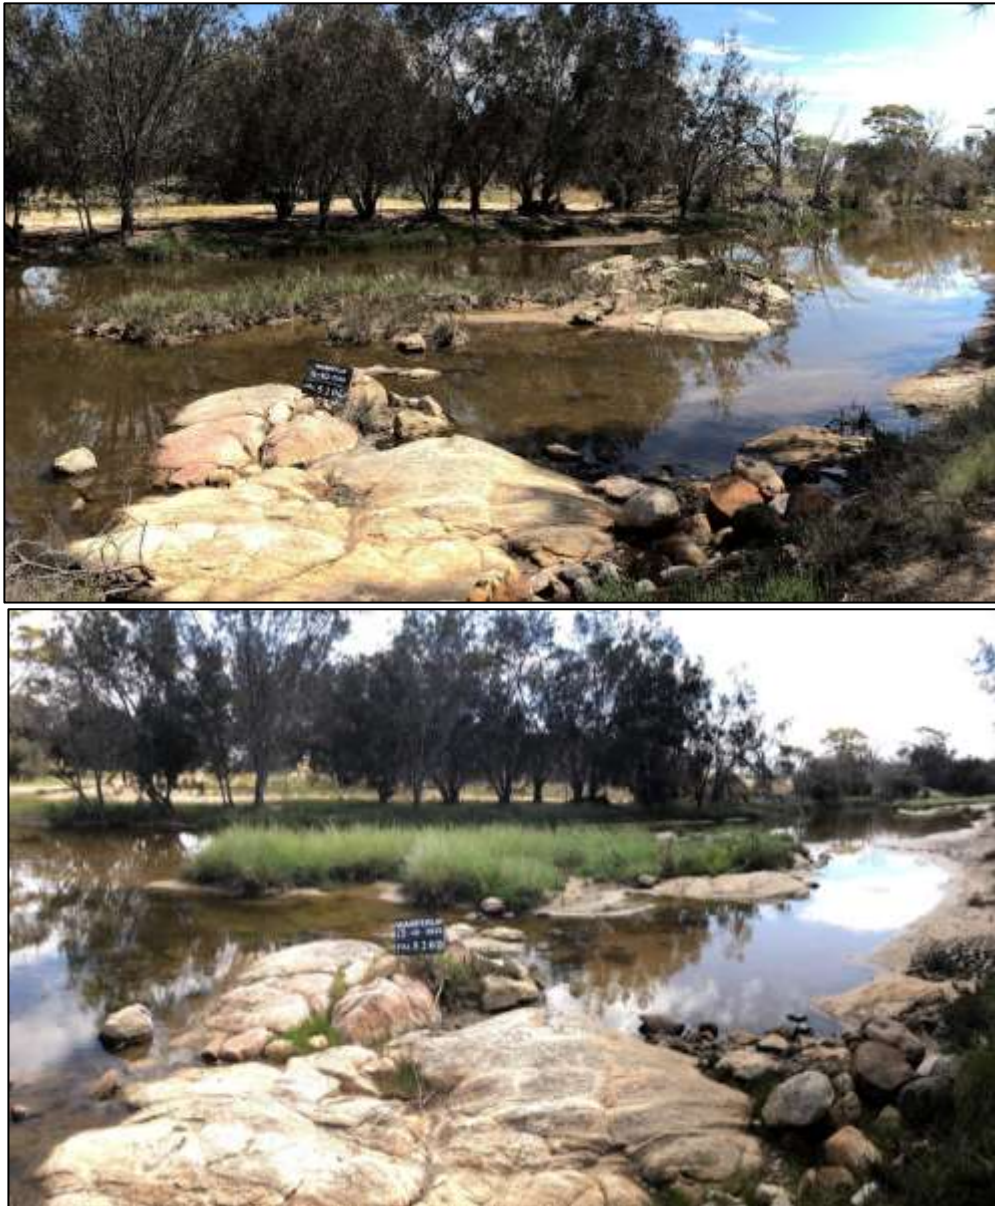
This site had the lowest aquatic diversity, and the most abundant taxa were midge, mosquito and brine fly larvae. Seed shrimps were present in abundance in 2020 and 2022 but were noticeably absent in 2021. In 2022, the TN values were very high, but the TP values were low. There was a benthic algal mat present in sections of the stream.

Figure 26: Sampling site PAL520, Mailerup / Long Creek in October 2020 above and 2022 below.

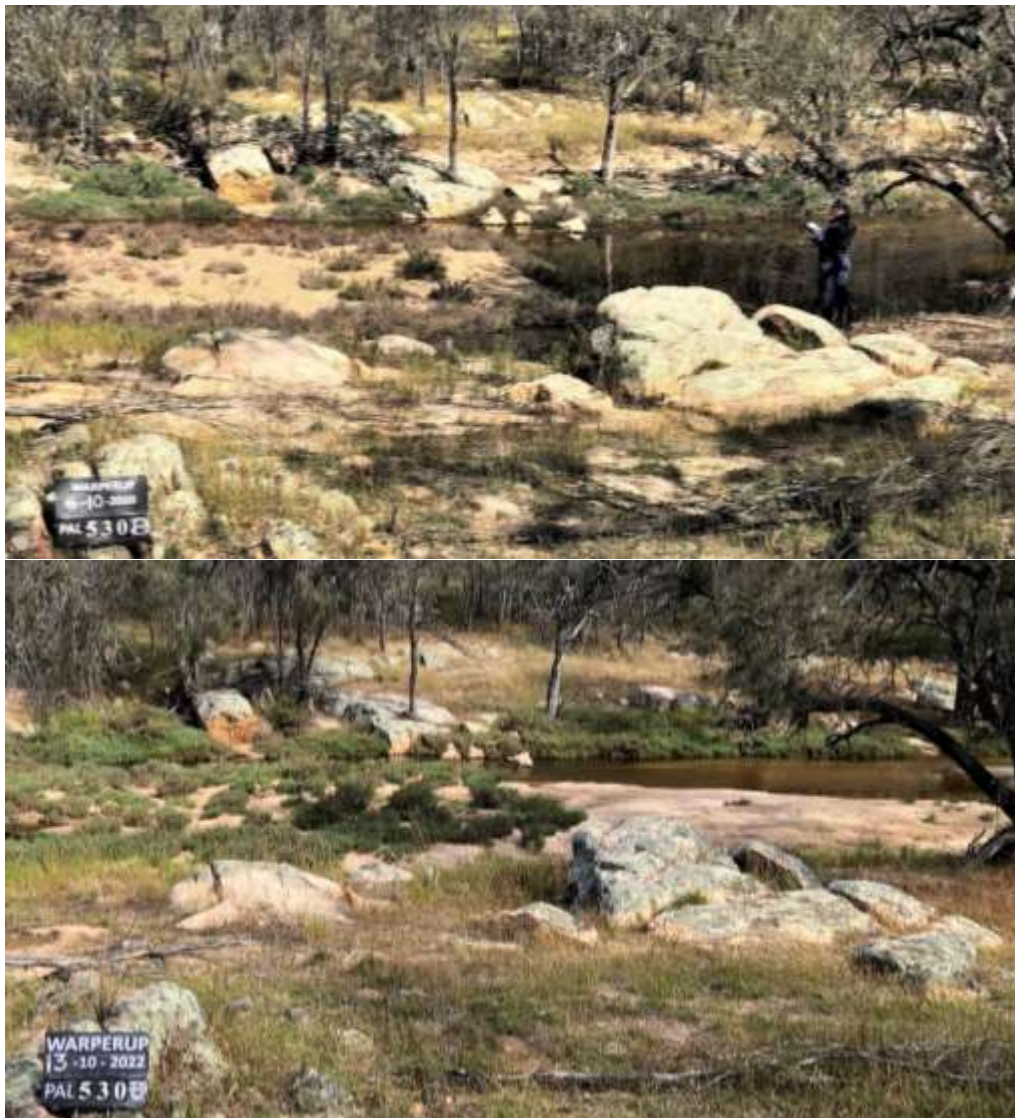
The water level at this site is controlled by a rocky bar a short distance downstream. The upstream reach is dominated by bedrock. Despite the high rainfall in June and July 2021 compared to 2020, the water depth was reduced in 2021 (see Figure 27 and Figure 28) due to an influx of sand. The Bureau of Meteorology daily weather observations for Ongerup show that in 2020 the area received 10.8mm rain in the four days preceding the 2020 sampling and in 2021 only received 3.4mm of rain. It should be noted that variations in water level can give the casual observer a misleading assessment of sediment quantities and movement.

Figure 27: PAL530B, Coromup Creek in October 2020 and 2022 showing increase in sediment in the waterway

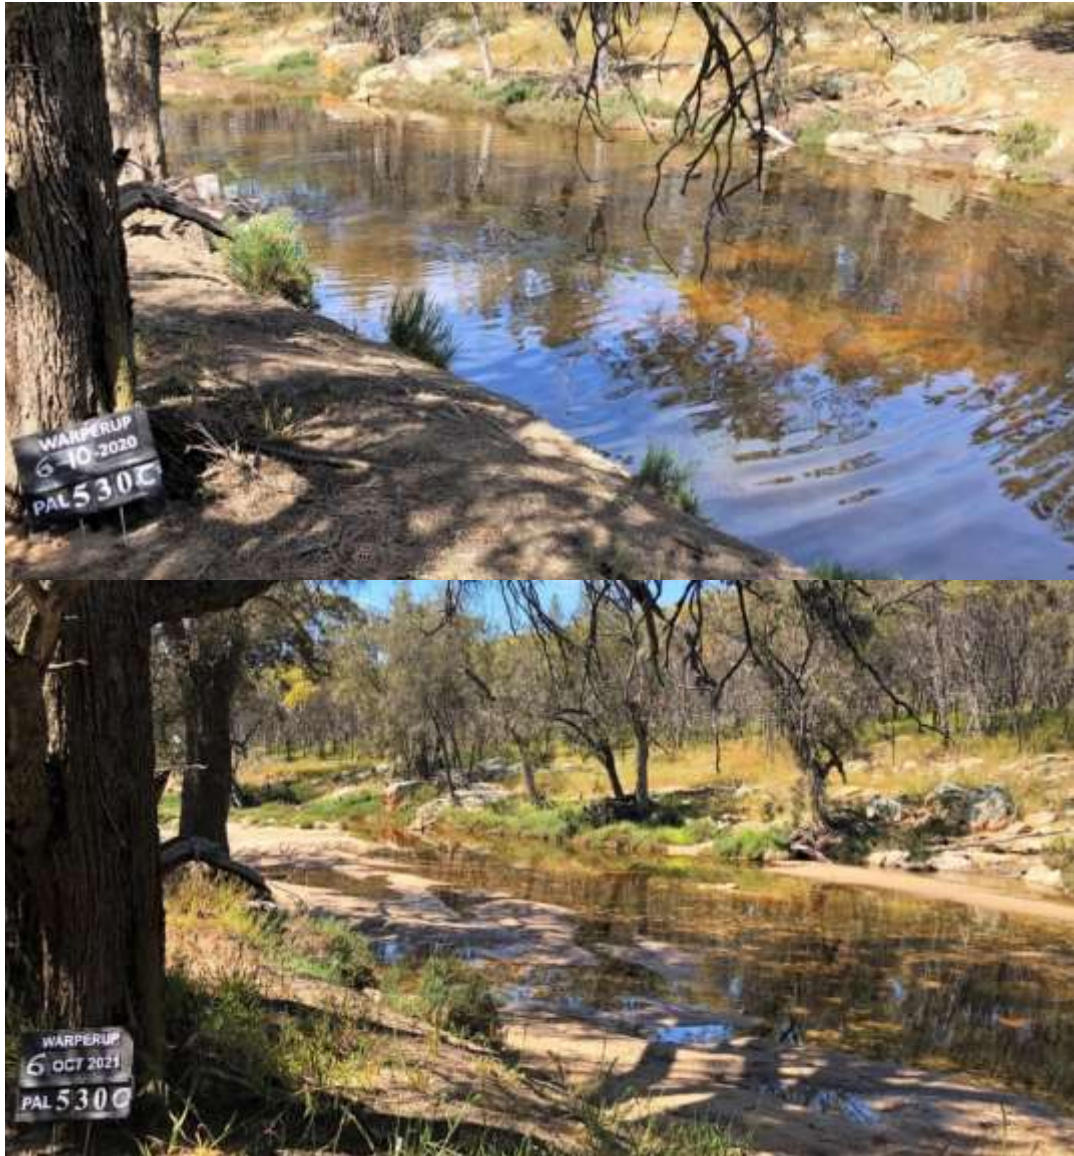
Figure 28: Sampling site PAL530C, Coromup Creek in October 2020 and 2021 showing increase in sediment in the waterway

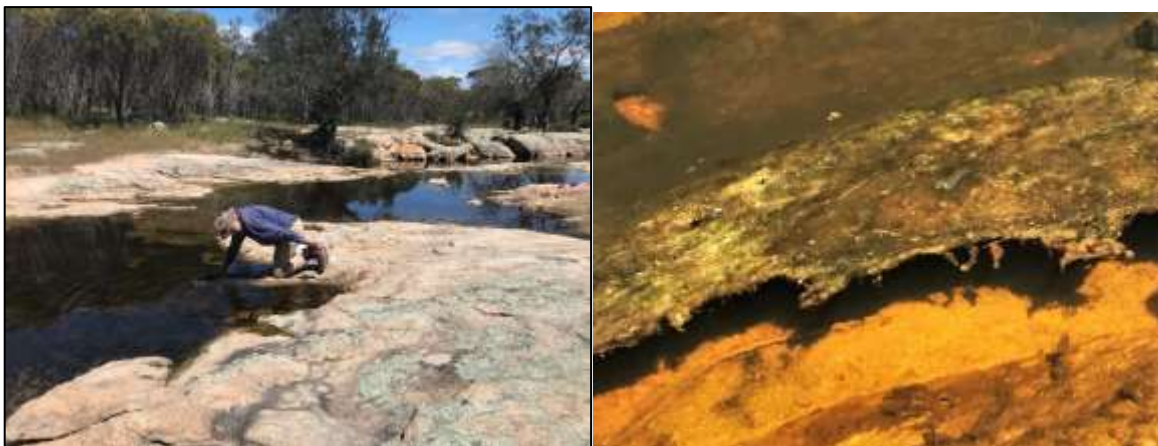
This site had a high Total Nitrogen concentration in the 2021 sampling round and a dense benthic algal mat on all sampling occasions (See Figure 29, right image). Despite this, the site had a reasonably high aquatic macroinvertebrate diversity with an abundance of seed shrimp, copepods, scuds, midge, and mosquito larvae. However, no fish were observed. This highlights the fact that ecosystems are defined by a wide range of features some of which may be quite subtle.

Figure 29: Left: Constraining rock-bar at site PAL530, Coromup Creek. Steve collecting a water sample. Right: a dense benthic algal mat producing Oxygen bubbles through photosynthesis which is lifting the mat off the sandy bottom.

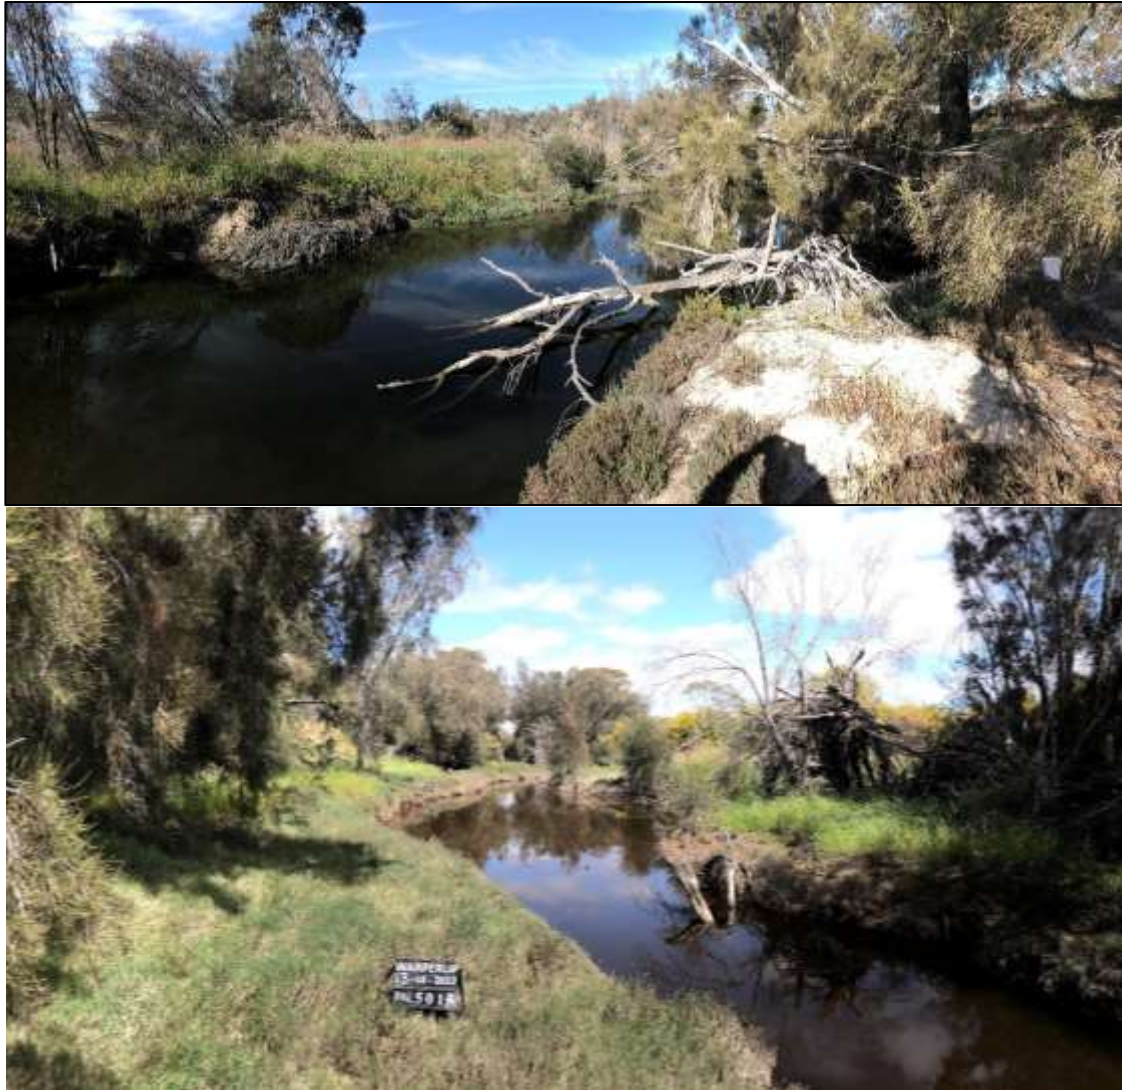
A water monitoring site was established at the Chester Pass Road Crossing in 1998-2000 by the then Water and Rivers Commission. For the 2020 monitoring program, the floodway adjacent to and extending upstream from the Golf Club house was chosen as the reference reach. The sampling location in 2020 and 2021 was downstream of the Club House but it was felt that the location was too difficult to access due to a very steep bank and the monitoring was relocated to a site upstream in 2022. See Figure 30 below.

Figure 30: Sampling site PAL501, Warperup Creek in October 2020 (above) and the new location PAL500A, upstream from the original site (below).

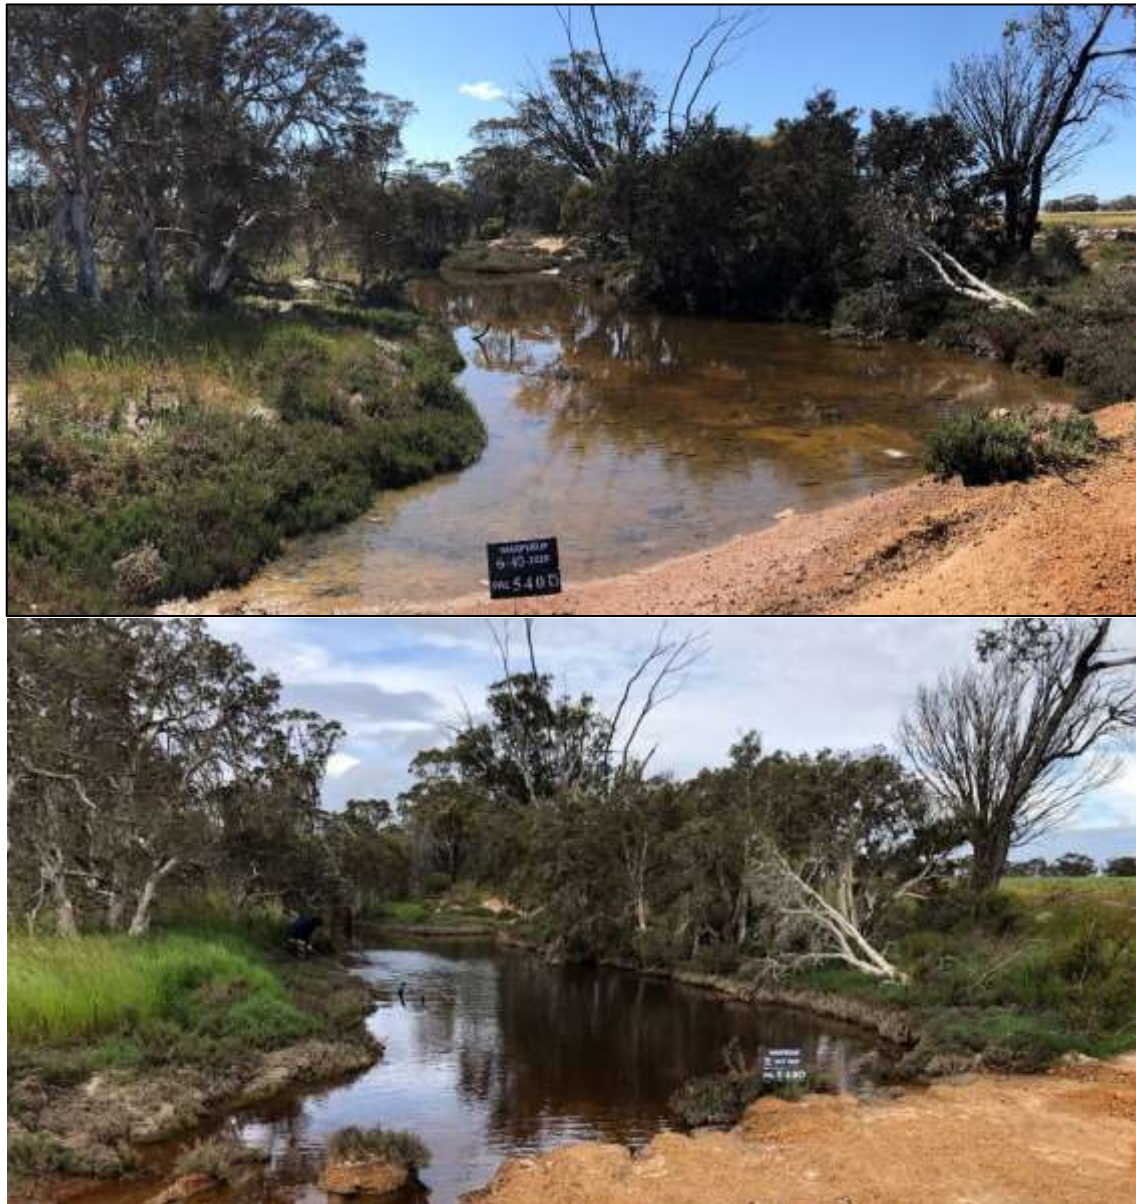
Aquatic diversity was slightly higher than most of the other monitoring sites with an abundance of *Coxiella* snails, copepods, scuds and midge larvae.

Figure 31: Site PAL540 on Peedillup Creek in October 2020 and 2021

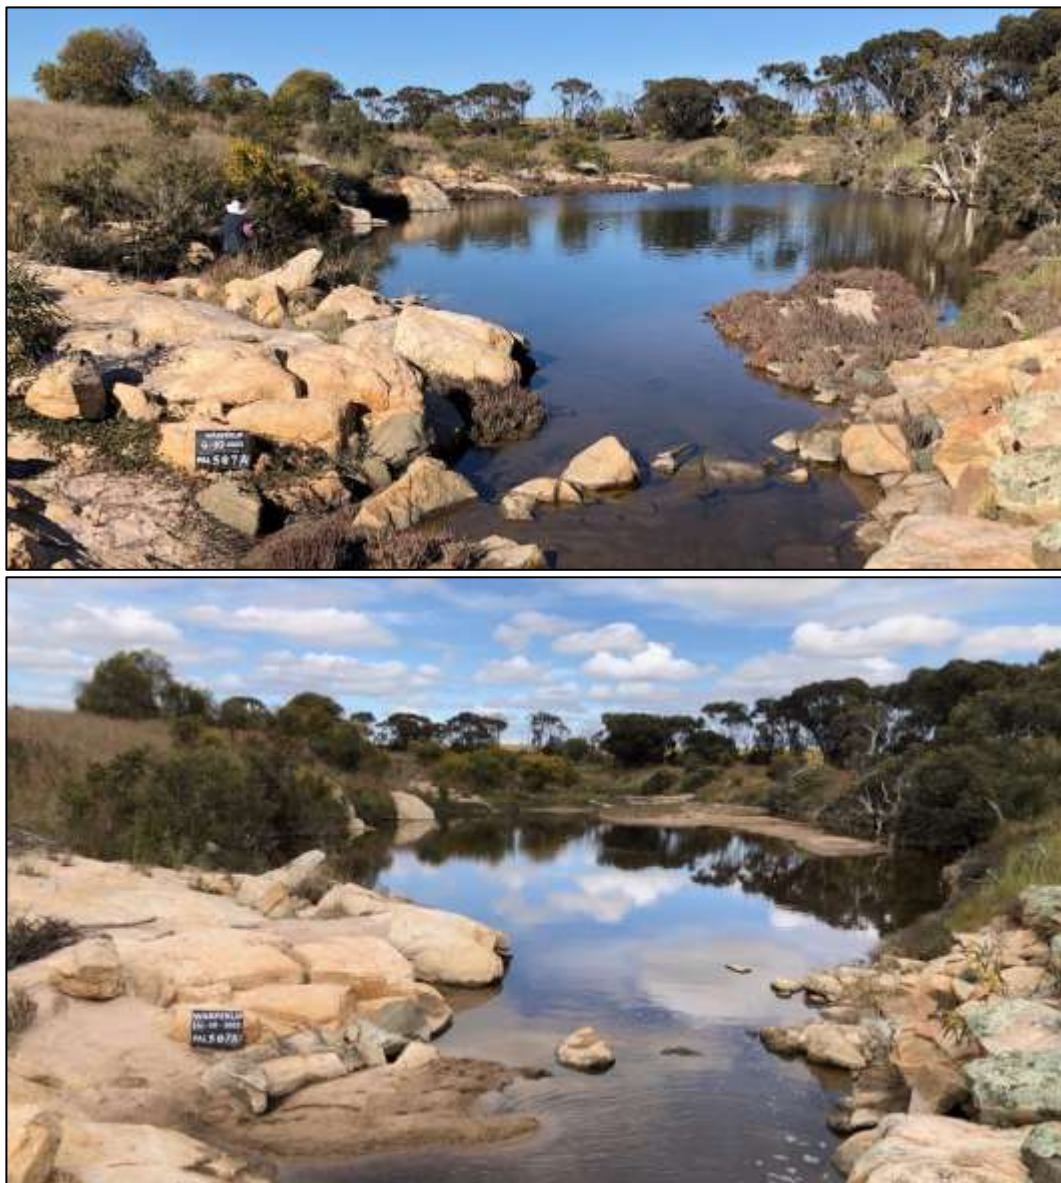
Sediment on near right bank (See Figure 31) has been stripped away during the previous 12 months and more sediment has been deposited at the downstream end of the pool. The water level in the pool in 2021 was higher than in 2020 which may be due to the sediment bar at the downstream end of the pool constraining the flow. The aquatic environment included an abundance of seed shrimps, scuds and midge larvae.

Figure 32: Site PAL507 on Warperup Creek in October 2020 and October 2022.

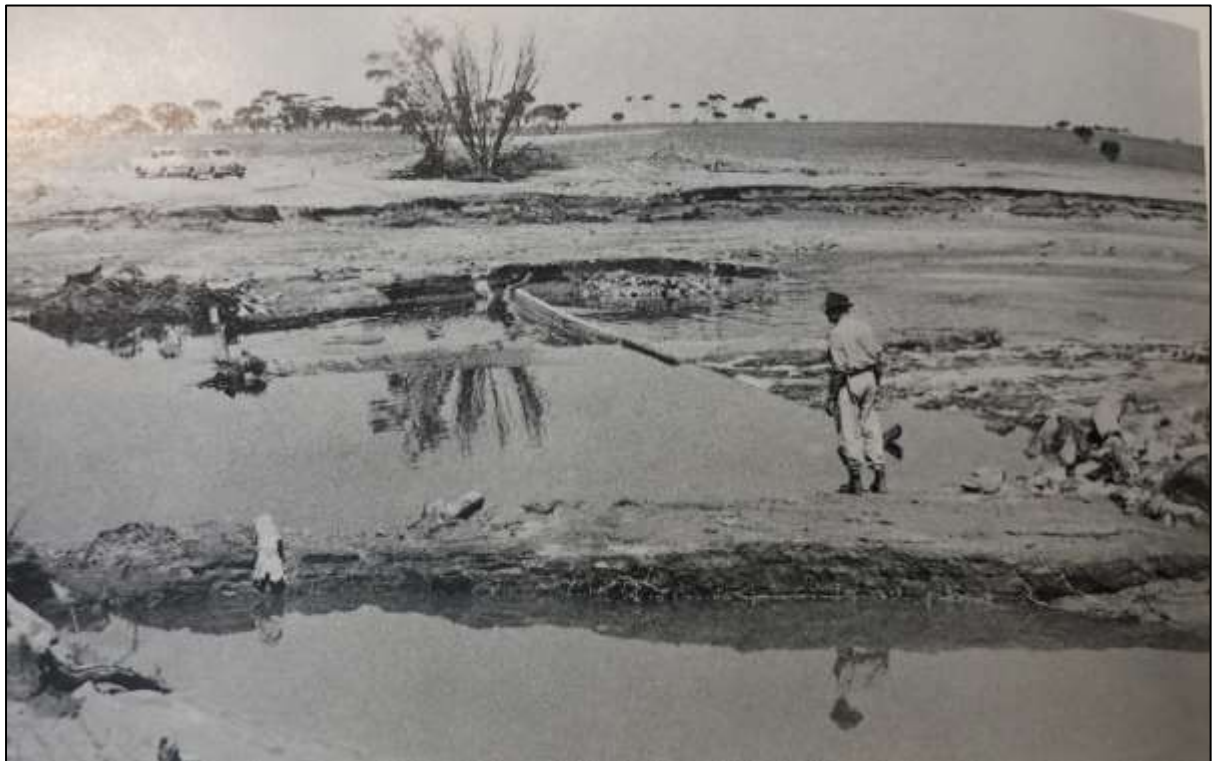
The image below (Figure 34) of a crossing on Warperup Creek also suggests that stream banks had been quite denuded.

Figure 34: A flood damaged crossing on Warperup Creek or Pallinup River 1955. (Source unknown)

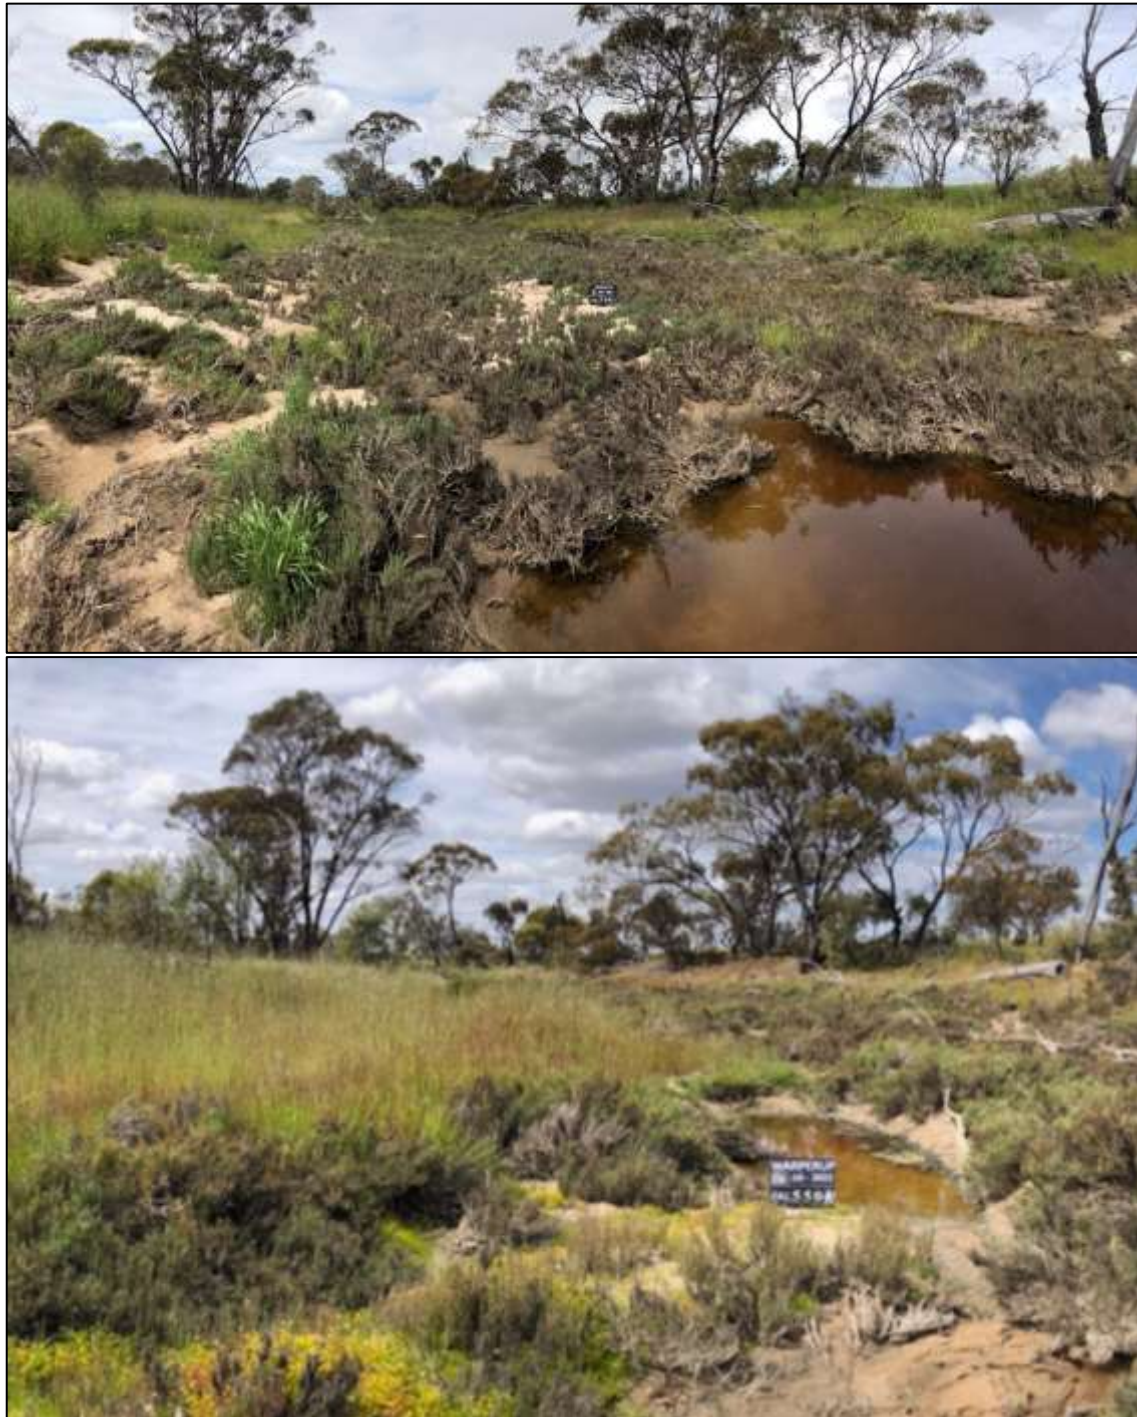
This site had the highest total phosphate level in 2022 and the highest NO<sub>x</sub>-nitrogen level in the 2020 sampling round. The aquatic environment was dominated by midge larvae, copepods and aquatic beetles.

Figure 35: Conditions at this site had remained much the same from 2020 to 2022

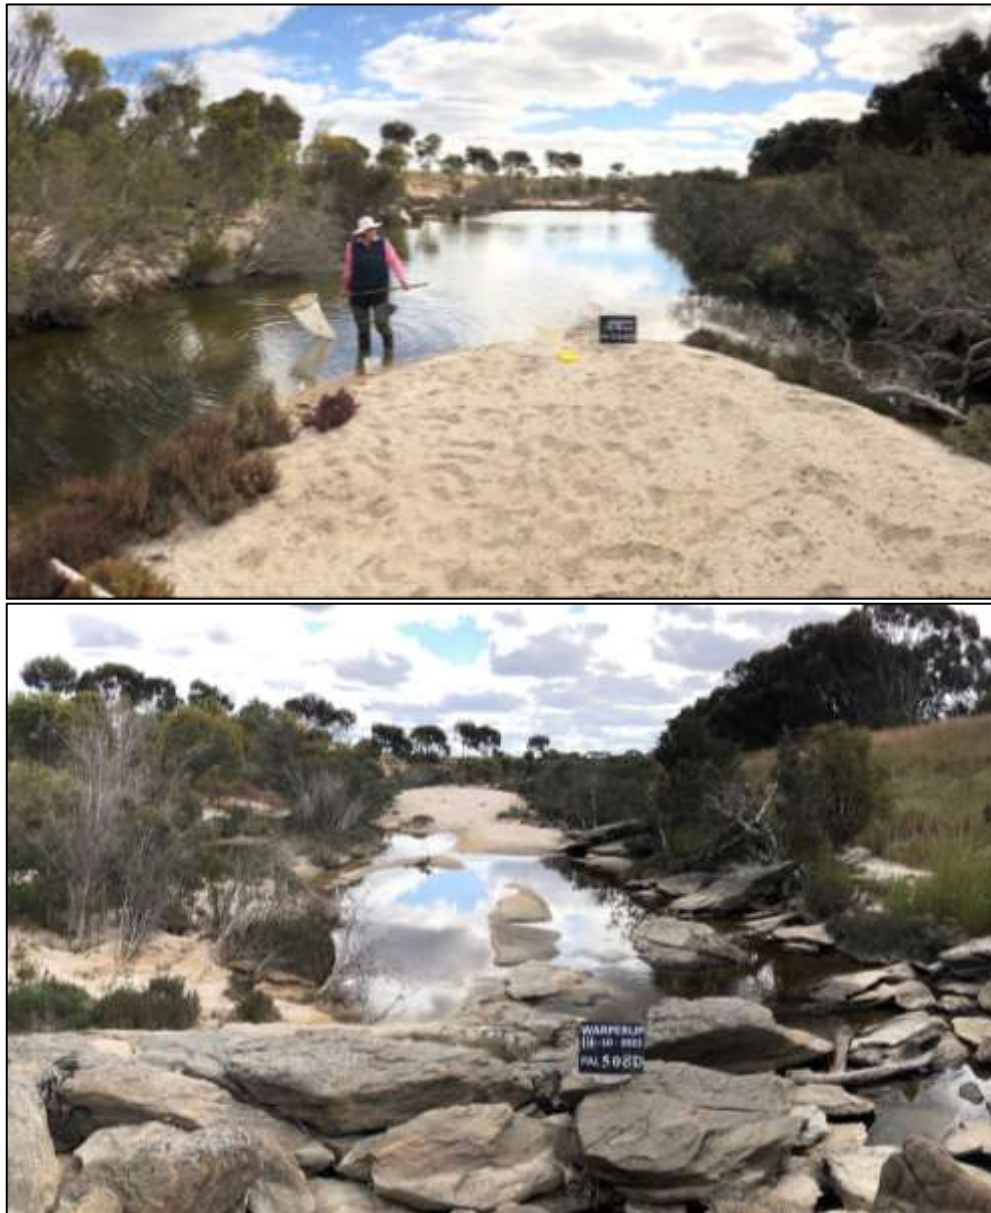
The sediment in this pool has been very mobile. See Figure 36 and Figure 37 below. The rocks in the foreground (2022) were exposed and sediment deposited in the downstream end of the pool. This indicates flows are actively moving large sand plumes. The aquatic macroinvertebrate diversity in 2021 was reduced compared to 2020 with fewer crustacean species but a higher dipteran fly and midge larvae diversity and abundance.

Figure 36: Site PAL508 on Warperup Creek downstream of Ongerup Creek in October 2020 and October 2021.

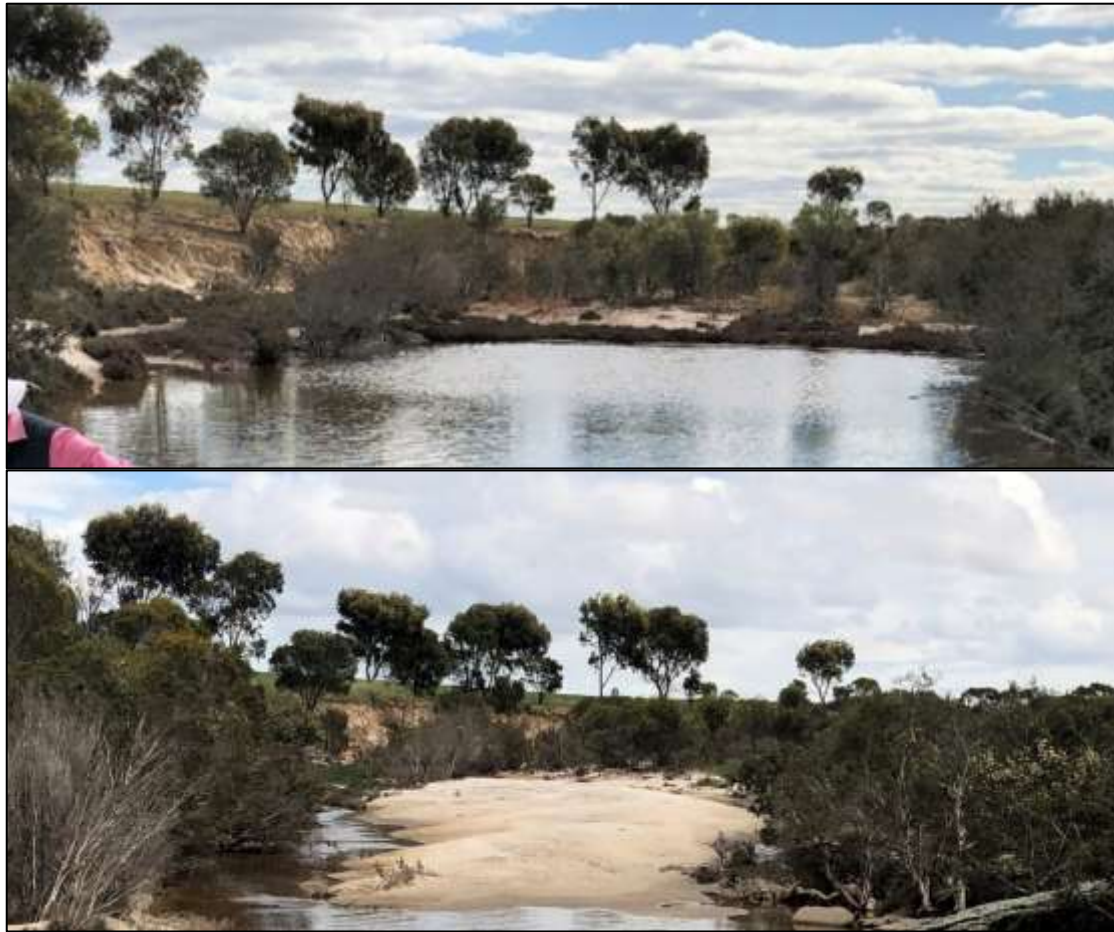
Figure 37: Zoomed in to the end of the pool at Site PAL508 on Warperup Creek, 2020 and 2021. Although the photo in 2021 was from a slightly different angle, the extent of sediment deposition can be seen.

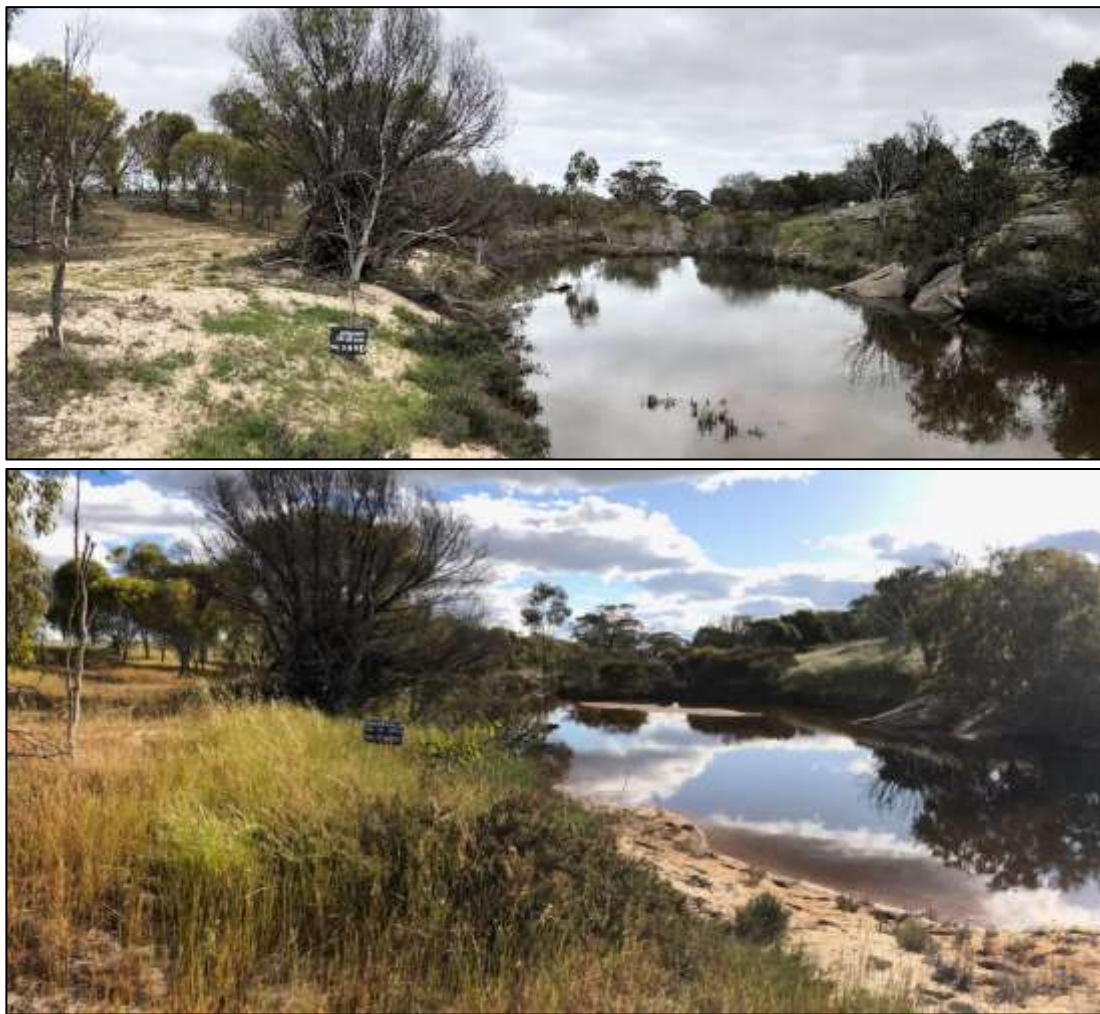
**Figure 38: Site PAL509 on Warperup Creek downstream of Jaekel tributary in October 2020 and October 2022.**

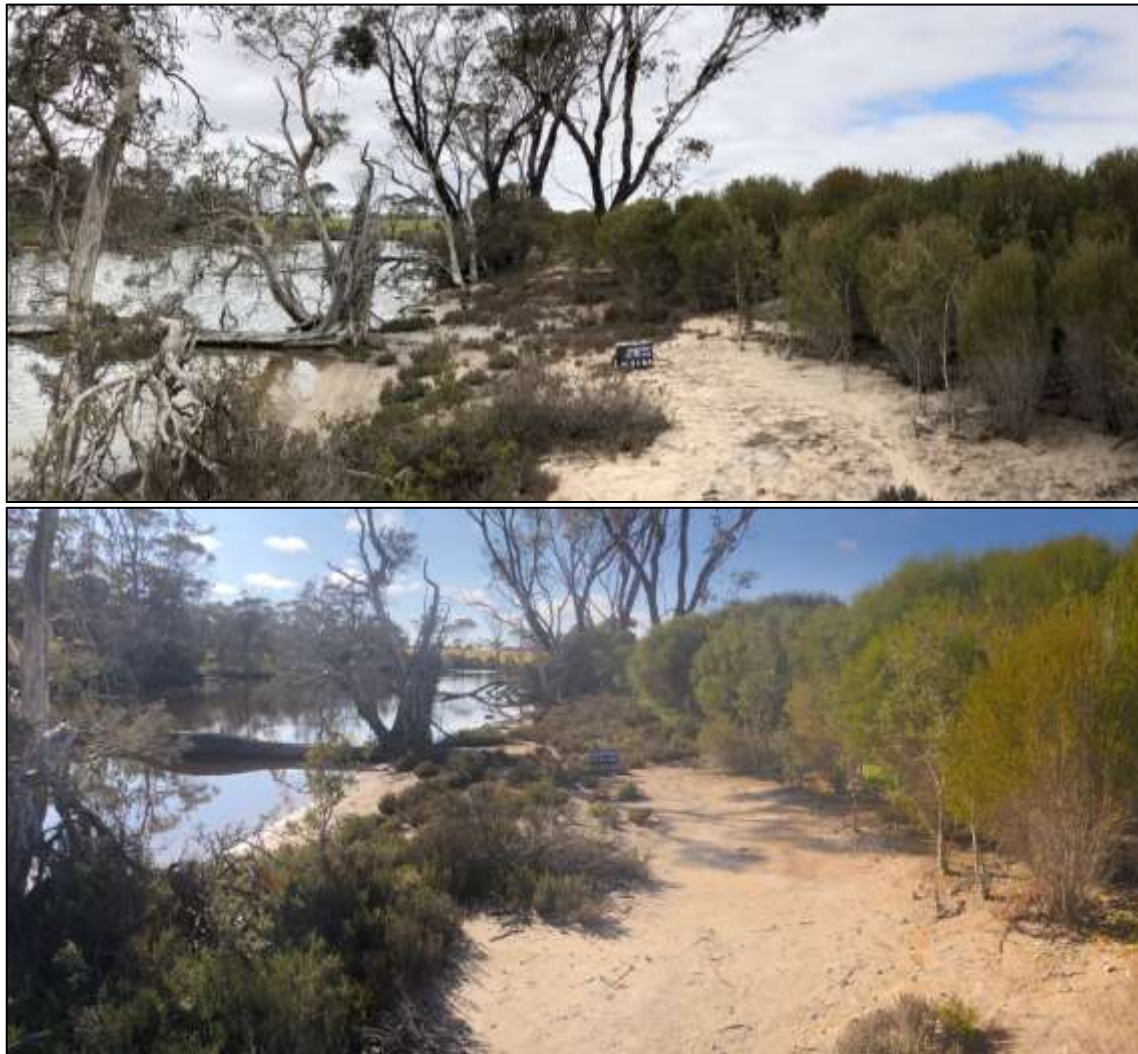
The aquatic environment was dominated by an abundance and diversity of seed shrimp, copepods, and scuds with midge larvae also abundant.

Figure 39: The upper most site on Warperup creek, Photo point PAL510 in October 2020 and October 2022.
