# Corackerup Creek and Chingarrup Brook

## Pool monitoring

by Steve & Geraldine Janicke

October 2016

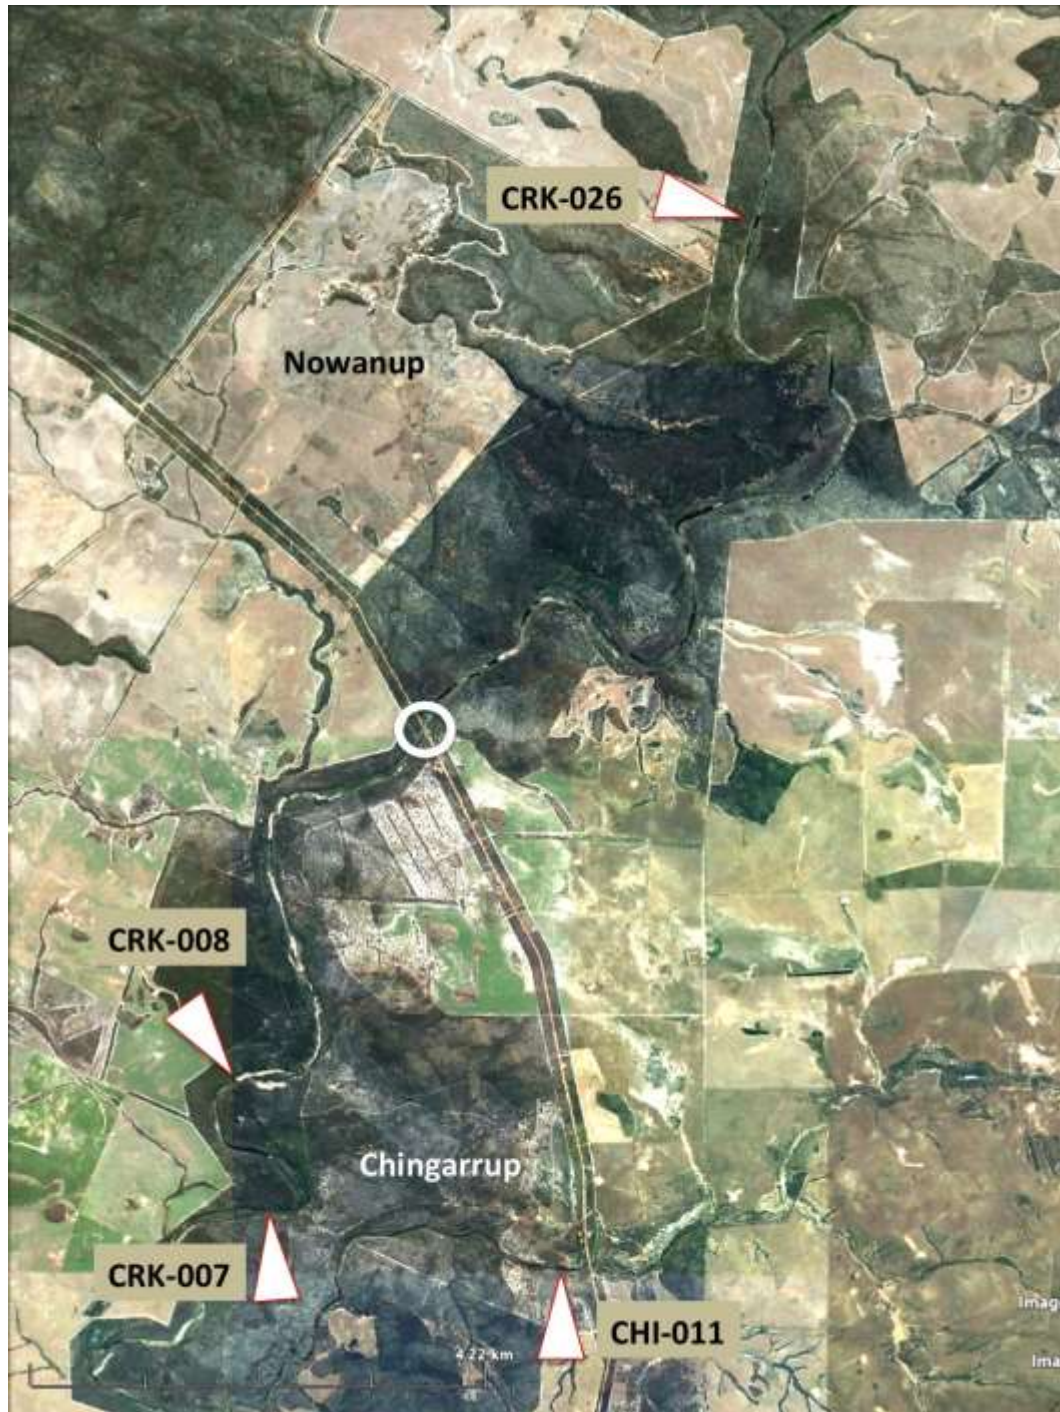
Figure 2: Pool locations and code numbers. The road shown is the Boxwood Hill - Ongerup Road

Four pools (Figure 2) were examined on the 26th and 27th of September 2016, one pool on the Chingarrup Brook and three on Corackerup Creek. The aquatic macro-invertebrate communities were examined and basic water quality measurements were taken. Depth soundings were taken on Chingarrup and one of the Corackerup pools, in order to give a broader context to the sampling environment. The findings are discussed below.

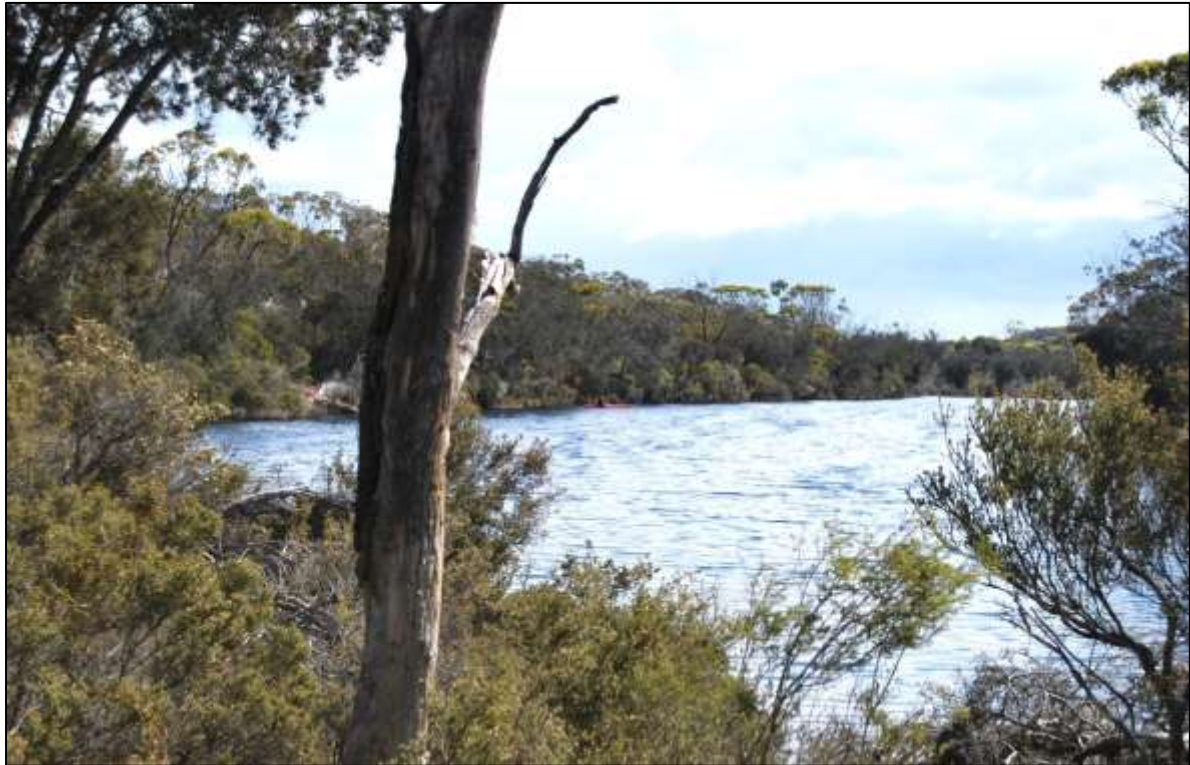
Figure 3 Pool CRK-007

- Approximate length of pool when full: 600 metres
- Maximum width: 40 metres
- Deepest point plumbed: 4.2 metres

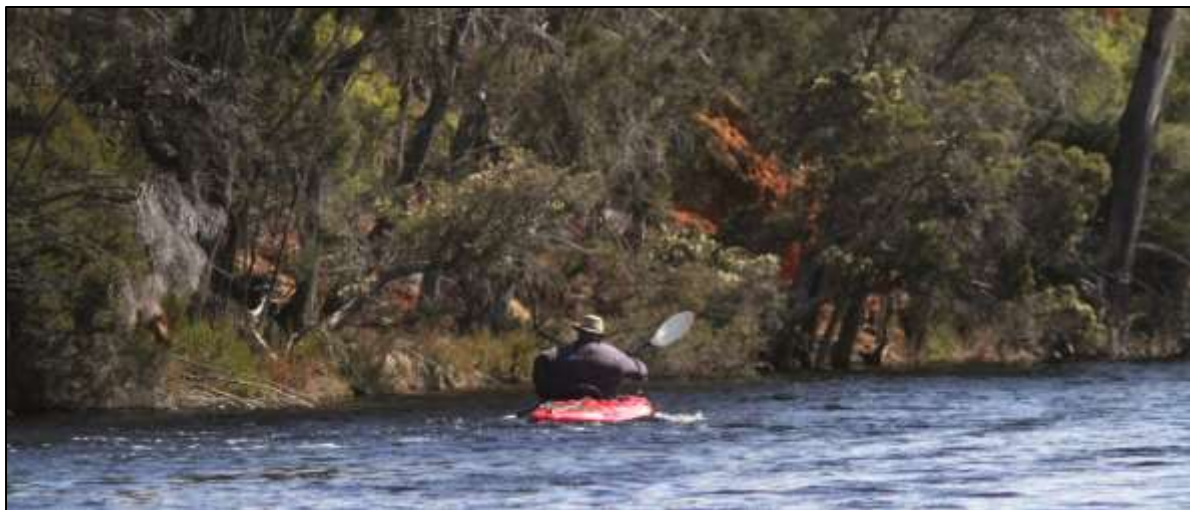
Two pools were plumbed using a lead line to obtain a basic longitudinal bed profile. The flows at the time of the assessment were sufficient to describe the pools as 'full'. No benchmarks were established to refer depths to, but Figure 3 and Figure 4 provide some context for what was meant by 'full'.

Figure 4: Pool CRK-007 showing distinctive trees and rock outcrops acting as water level bench marks.

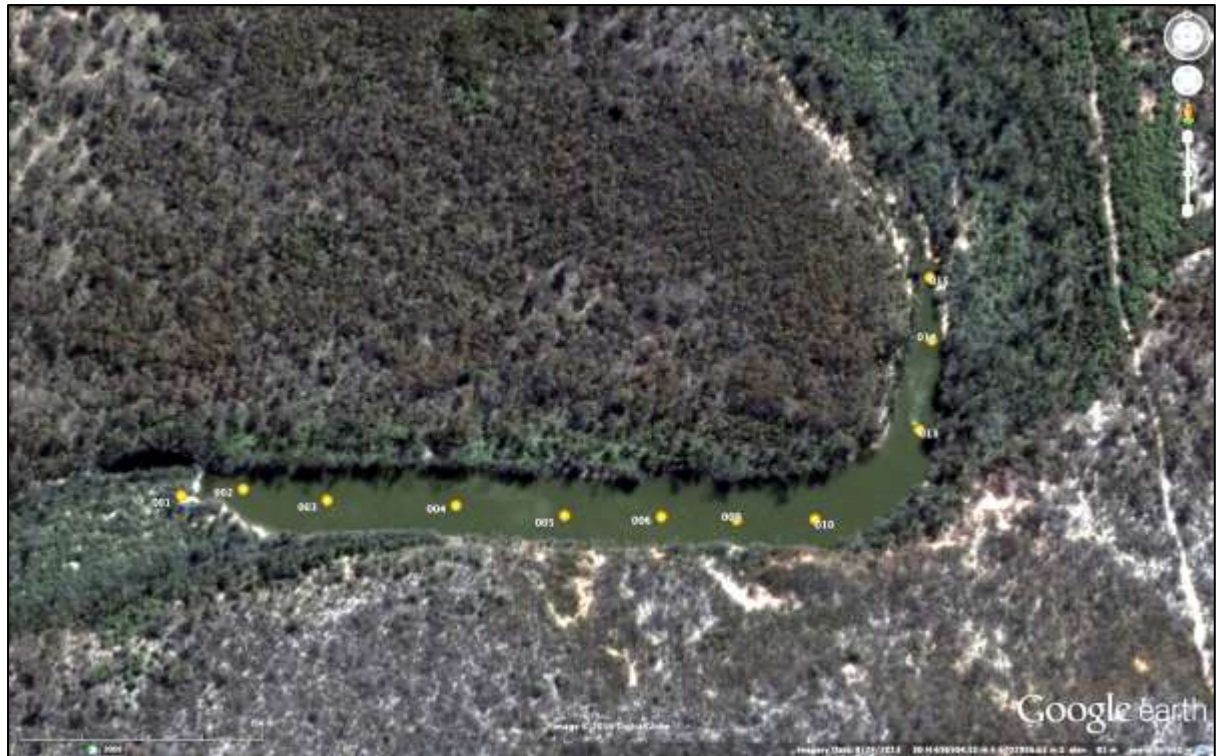
Figure 5: Corackerup pool CRK-007 bathymetry points

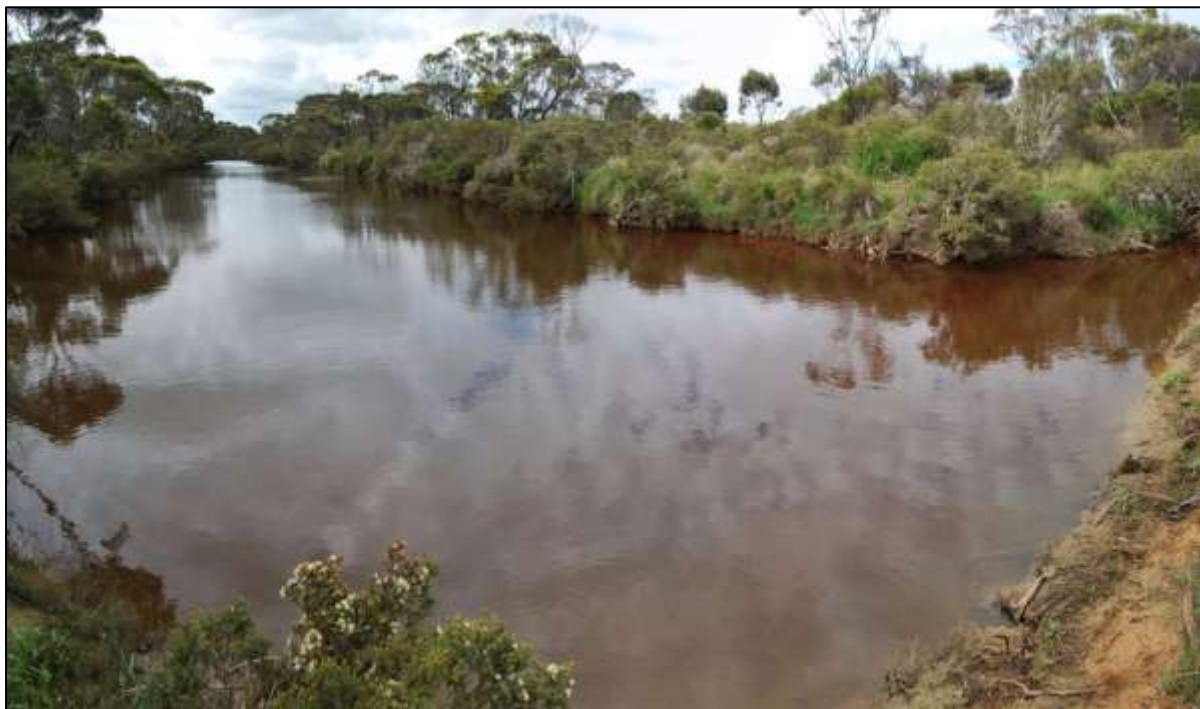
Figure 7: Pool CHI-011 showing the view upstream from the lower end at the time of sampling.

- Approximate length when full: 180 m
- Maximum width: 20 m
- Deepest point plumbed: 1.1 m

The brownish colour was due to the bed being partly visible through the shallow waters and partly due to turbid conditions. The turbidity value was 50 NTU suggesting that suspended sediment, as well as tannins, contributed to the colouring. No bottom sample was taken at Chingarrup pool CHI-011 as the depth was rarely more than 0.7 metres and the waters were well mixed due to wind action and a steady in-flow from at the time of the assessment.

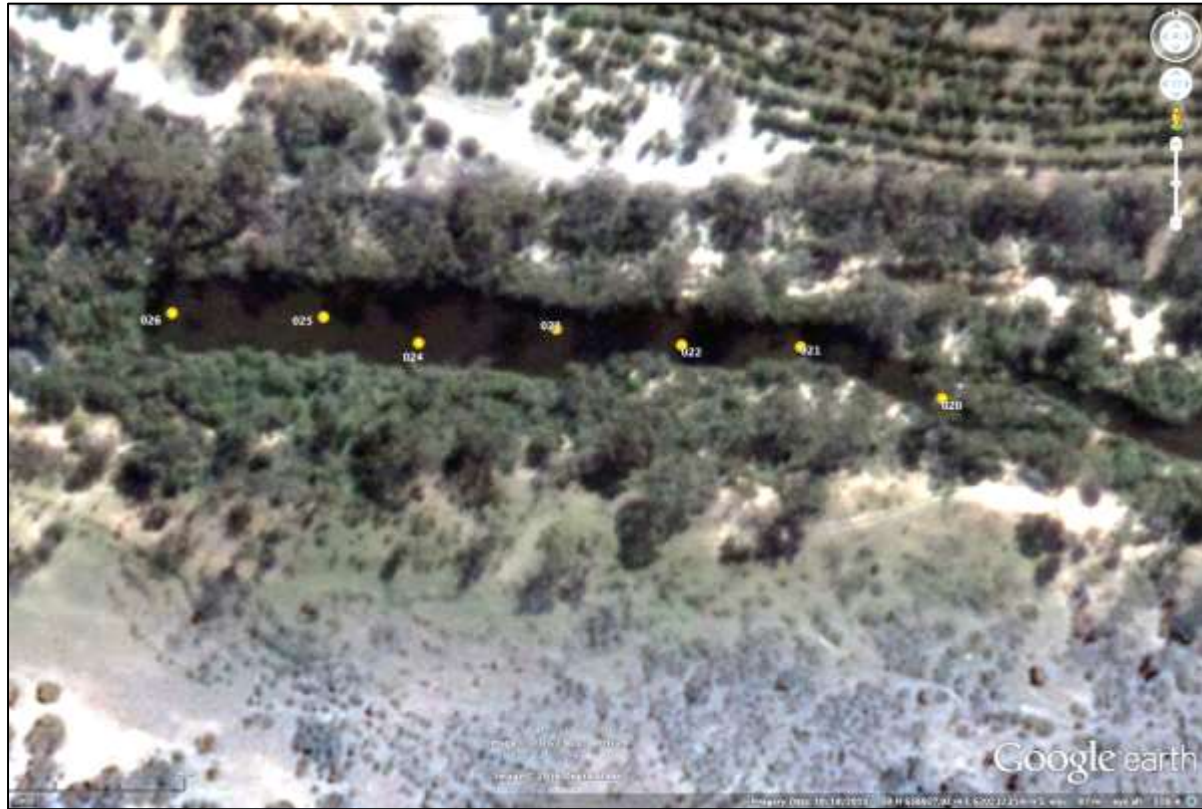
Figure 8: Pool CHI-011 showing the depth sounding points along the pool

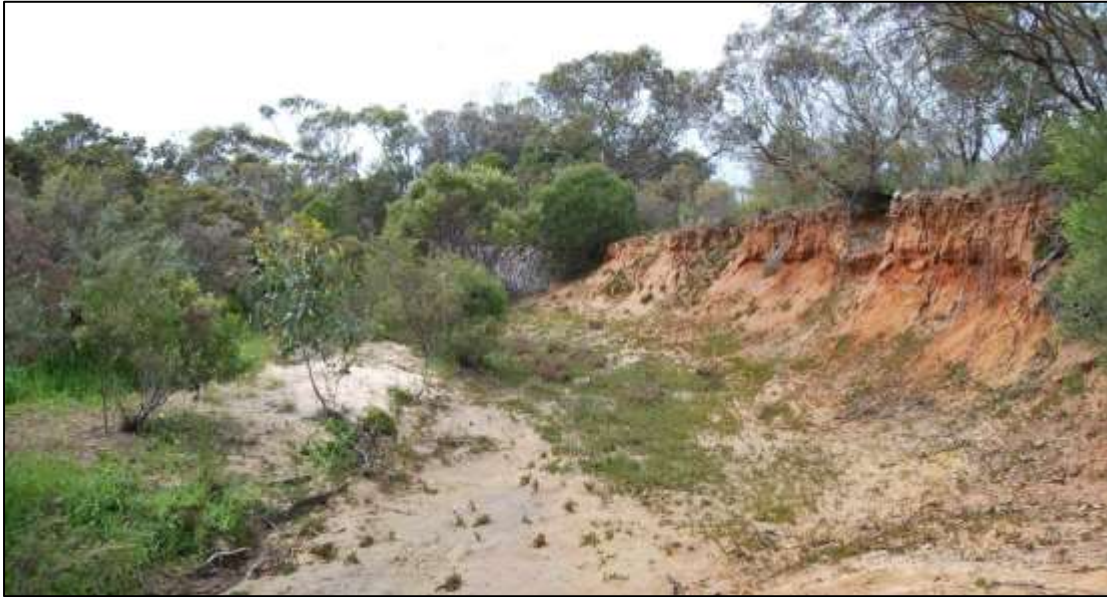
A large scour (Figure 10 looking upstream) along the left hand bank below the pool indicates that flood flows have been directed to that side. Local loss of vegetation along the top of the bank may have weakened this section and this illustrates the important stabilizing effect of the fringing vegetation. Deposition of sediment in the center of the channel is likely to have contributed to deflecting flows. An active head-cut (waterfall) adjacent to the scour (Figure 11) is also an indication that a number of flood flows have concentrated along the left bank over past years. A granite bar (Figure 12) across the channel further downstream places some limit on upstream bed deepening, but it is uncertain how further bed erosion might alter the pool environment.

Figure 10: An older flood bypass scour along the left bank a short distance below the pool CHI-011.

Revegetating the toe of the flood scour, with deep rooted plants and sedges, may afford some protection to the bank and reduce local contributions to the sediment load in the creek.

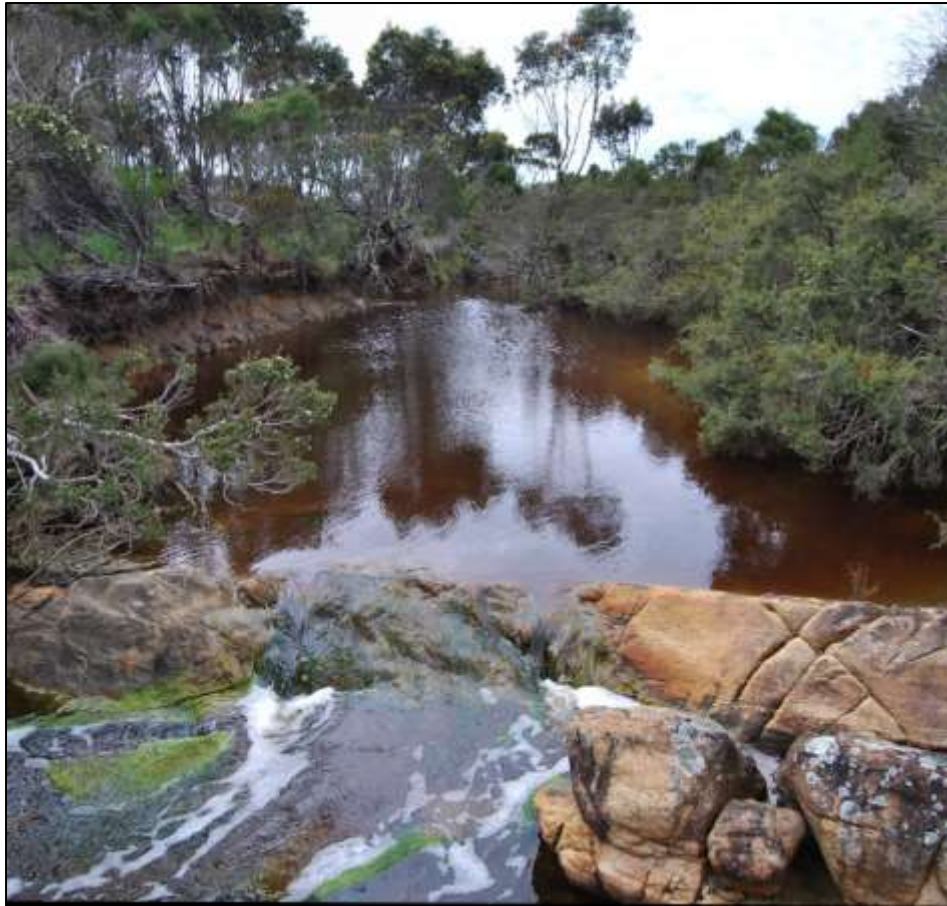
**Figure 12: The rocky bar (looking upstream). Note the active bank undercutting opposite the well vegetated bank and indicating that flood flows have been deflected to the opposite side (north bank) of the channel downstream of the scour shown in Figure 10.**

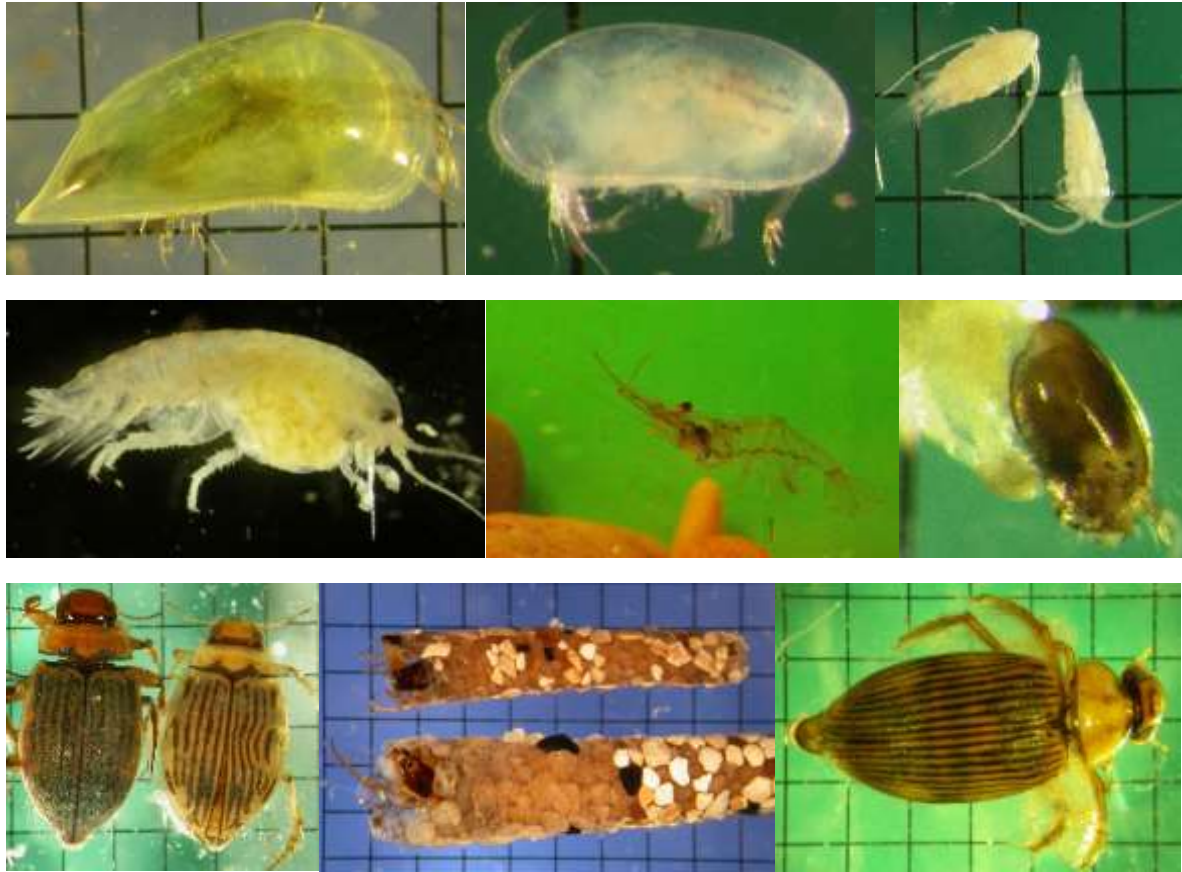
Figure 15: Macroinvertebrates found in the Corackerup and Chingarrup pools. Top row: Ostracods, *Mytilocypris mytiloides/henricae* & *Ilyodromus* sp. and Calanoid copepods. Middle Row; Amphipod *Austrochiltonia subtenuis*, Shrimp *Palaemonetes australis* and the Chironomid *Dicotendipes conjunctus*. Bottom row; Dytiscid diving beetle *Necterosoma penicilatus*, Caddisfly larvae *Symphitoneuria wheeleri* and Hydrophilid scavenger beetle *Berosus dallasae*.

Three species of macroinvertebrates were found in all four pools, a Calanoid copepod, a midge larvae *Dicrotendipes conjunctus* and a caddisfly larvae *Symphitoneura wheeleri* (Figure 15Figure 14). The caddisfly larvae is endemic to southern Australia preferring saline waters. Several estuarine species were collected including the mussel, *Fluviolanatus subtorta* and the shrimp *Palaemonetes australis*. Both these species are present throughout Australia.

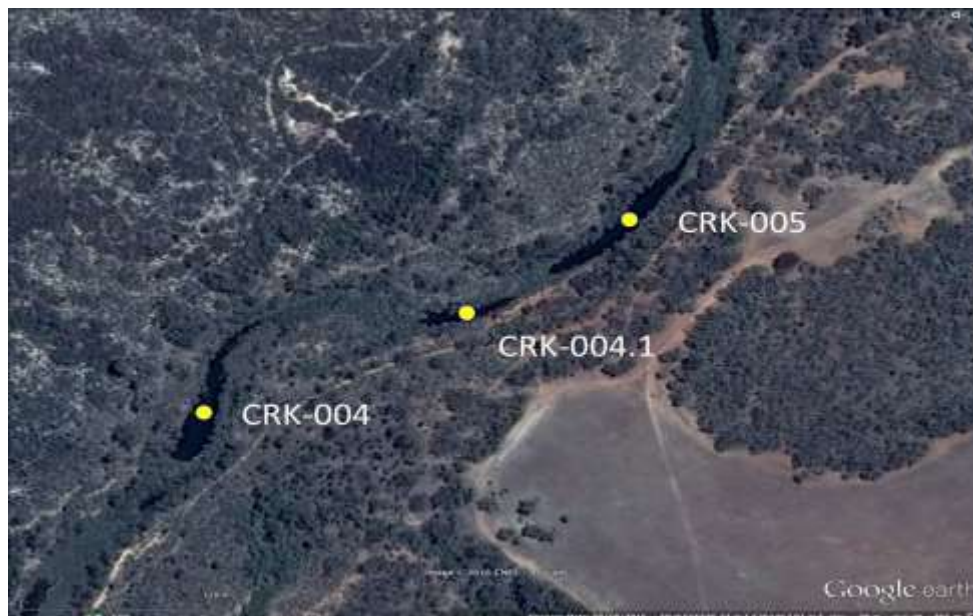
**Figure 21: Intermediate pools are labelled using a decimal point.**

A pool audit is done as a desktop exercise and pools longer than 100 metres are numbered starting at the lowest in the catchment or sub-catchment. The authors have employed an alpha-numeric code to identify pools, with the first three letters representing the name of the river or creek, followed by 3 digits. The first pool upstream of the river or streams downstream end point is 001. For example, CRK-001 and CRK-004 are the first and fourth pool on the Corackerup Creek, upstream of the Pallinup River confluence. Pools that are under 100 metres in length can be included in the audit by using a decimal point. Thus CRK-004.1 is an intermediate pool between CRK-004 and CRK-005 (Figure 21). This also allows smaller pools to be added to the coding system without changing the basic numerical sequence.
