# **YOUNG RIVER CATCHMENT**

## **FARMERS ROAD CREEK**

### **STREAM REHABILITATION DEMONSTRATION REACH**

#### **SITE ASSESSMENTS & OUTCOMES**

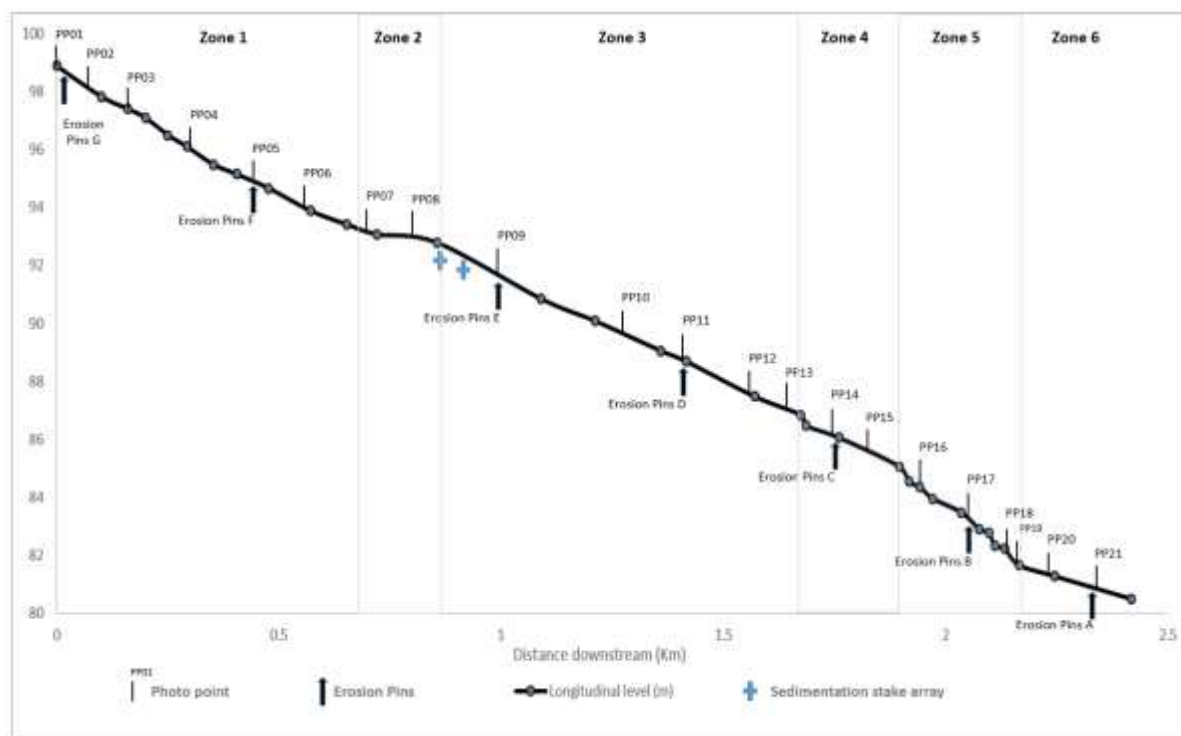
**Figure 7: The longitudinal bed-slope of the demonstration reach and indicates the location of photo points, erosion pins and stakes.**

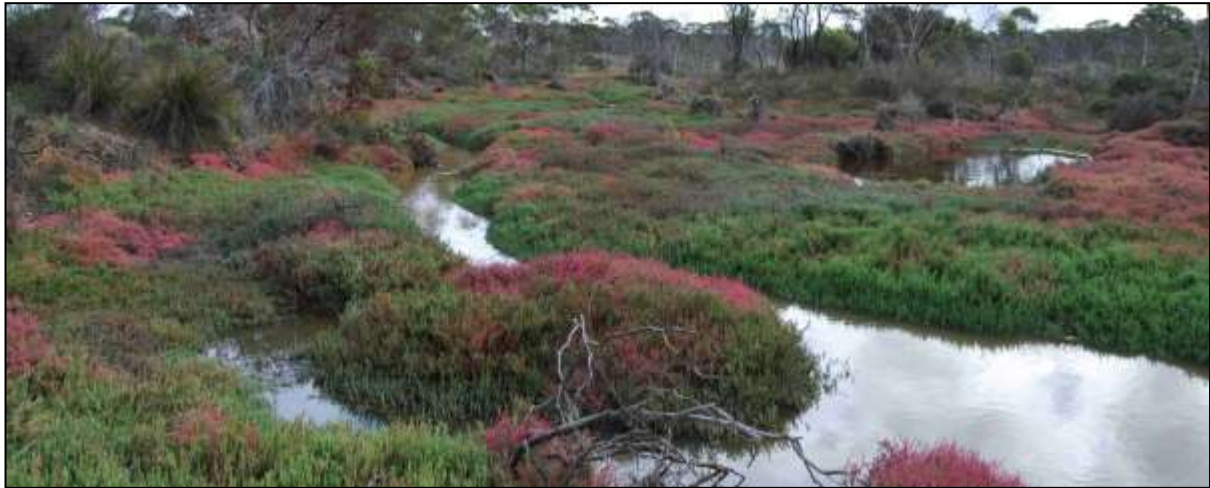
**Figure 13: Looking upstream from the Young River Reserve boundary (2011)**

The consequence of bed and bank erosion is sediment moving downstream. Excess sediment overwhelms many small and medium sized riparian habitat features that support a diversity of terrestrial and aquatic organisms. The food chain is broken at the most basic level. Accumulating sediment along the valley floor has important consequences for rehabilitation by dividing the flow path into many shifting channels and backwaters. This is well illustrated looking upstream from the boundary between the Young River Reserve at the lower end of the creek system and into the farmland. Figure 12 shows that Samphire has clearly found this suitable for colonisation. One undesirable outcome may be increased mosquito populations. Rehabilitation in these areas will not look like the original riparian form.

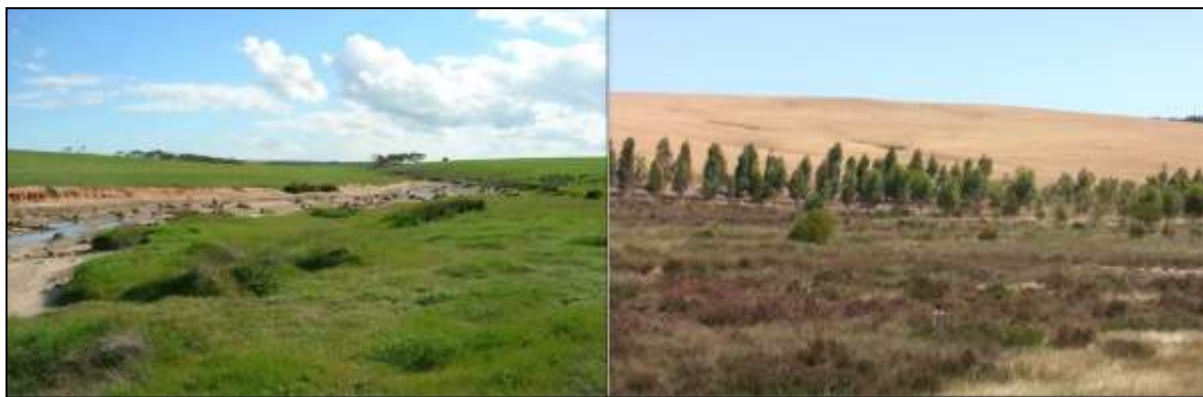
Although revegetation at the Yerritup Creek site bears little resemblance to the pre-clearing form of the channel, signs of which were observed downstream, a significant environmental outcome has been to stabilise the bare scalded areas. This serves to reduce bed and bank erosion and the movement of sediment downstream.

Figure 18 Yerritup Creek Site looking upstream (2005) and looking across the floodway (2011).

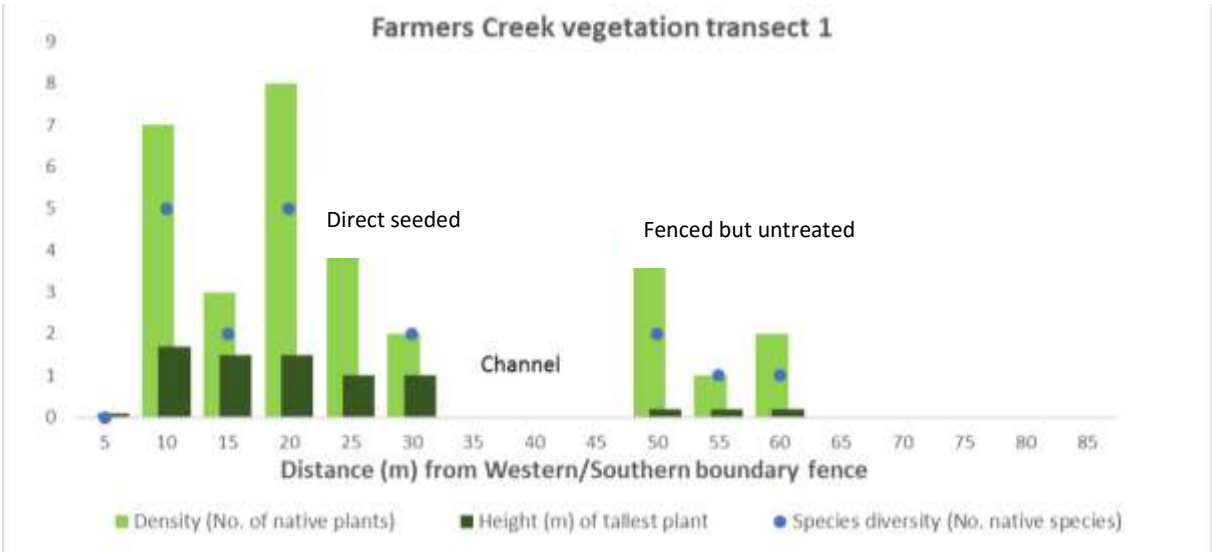
Vegetation Transect 1

Figure 20: Plant density (number of native plants), height, and species diversity (number of native species) for Transect 1.

The measure for ‘percentage plant cover’ was similar for both sides of the channel with pasture grasses and weeds also covering the ground. Yet the Photos (Figure 21 and Figure 22) show the distinct difference with direct seeding on the western (right) bank. The measures; ‘height of tallest plant’, number of native plants’ and ‘number of native species’ are more instructive to the change with revegetation.

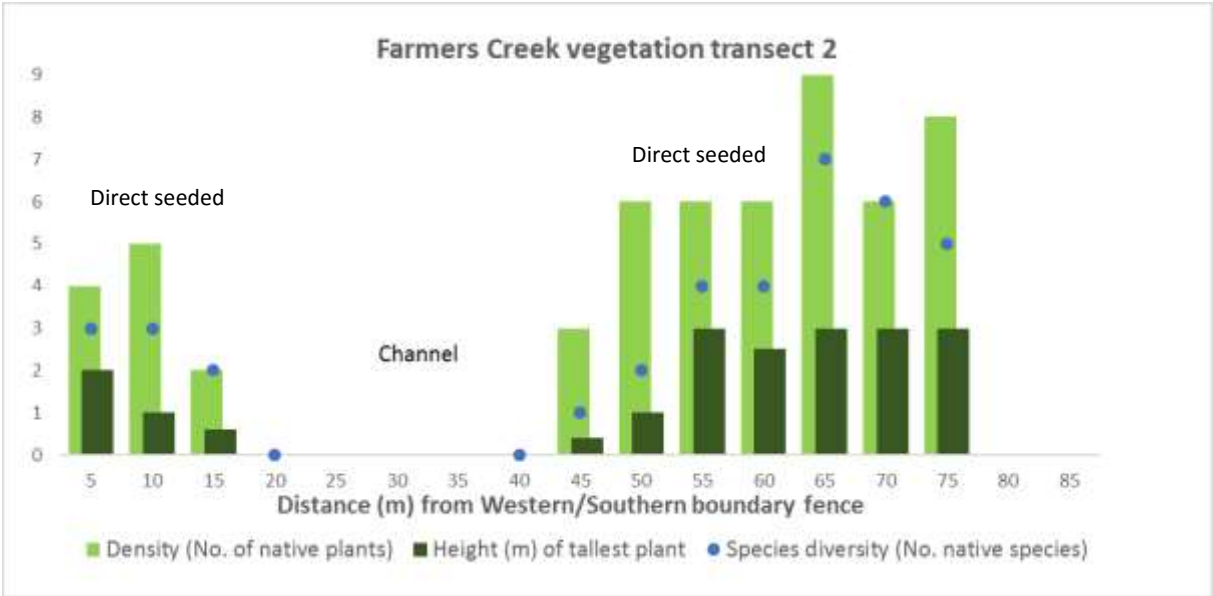
Vegetation Transect 2

Figure 23: Plant density (number of native plants), height, and species diversity (number of native species) for Transect 2.

At transect 2, both sides of the Creek were direct seeded, however the left (northern) bank shows a higher density of species and planting. The graphs suggest there is an edge effect within 15 metres of the channel where vegetation height, density and diversity are reduced.

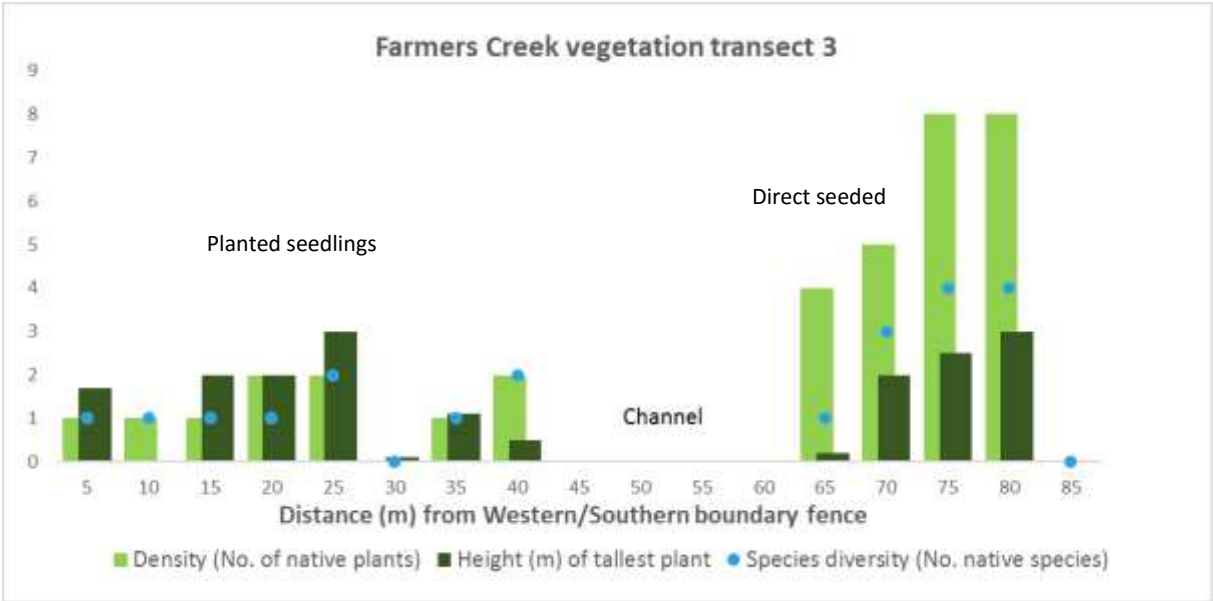
Vegetation Transect 3

Figure 26: Plant density (number of native plants), height, and species diversity (number of native species) for Transect 3.

The left (western) bank which was planted with seedlings shows the decreased density of planting and reduced number of species when compared to the direct seeded area on the right (eastern) bank.
